Metallurgical Analysis of Fatigue Failure in Submerge Chain Conveyor

Ash handling unit is one of the crucial part of the operation of a coal fired power plant (CFPP). This paper focused on the investigation of shackle chain failure in ash handling unit of a 600 MW CFPP. The failure caused disruption to the operating system of the CFPP. To improve the chain system in order to prevent similar failure in the near future, the metallurgical failure analysis was conducted on failed shackle chain through crack observation using optical and electron microscope and Vickers hardness test. Crack surface observation of failed shackle chain using Scanning Electron Microscope (SEM) revealed that the failure of shackle chain was primarily due to the fatigue failure which was proven by the presence of beachmarks. In addition, there were two initial cracks which were caused by pitting corrosion. The clearance (gap) occurred in the bolt connection system caused the fatigue load which in turn resulted in failure to the CFPP operation. This research suggested preventive measures to be taken to avoid similar problem in the future.

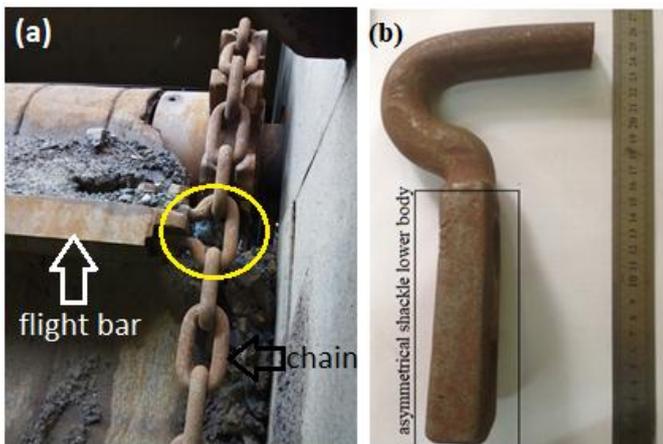
Fig 1. The shackle chain when in use as indicated by yellow circle (a) and the failed shackle chain (b).

It can be seen in Fig 1a, the shackle chain is connected to the chains and flight bar while in Fig 1b, the failed shackle chain was corroded indicated by light brown referring to iron oxides and it was torn into two sections. This failed component was taken for further investigation. The type of shackle chain used was padless shackle connectors with double bolt chain connecting shackles and the terminology used in this paper is briefly shown in Fig 2.

The evidence showing the increase of gap (clearance) between the upper and lower body in connection systems had occurred was clearly shown in Fig.1b in which the lower body was not symmetrical. Thus the failure of the shackle chain was preceded by the occurrence of pitting corrosion on the outer surface of the crown area and the dynamic load due to clearance which occurred in the bolt and nut system causing propagation of cracks and finally the fracture occurred.

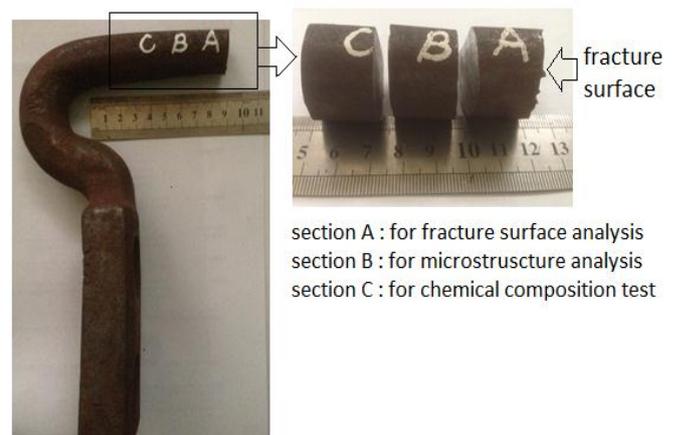
Fig.3 Three samples with each letter A, B and C, taken from the broken shackle chain for investigation

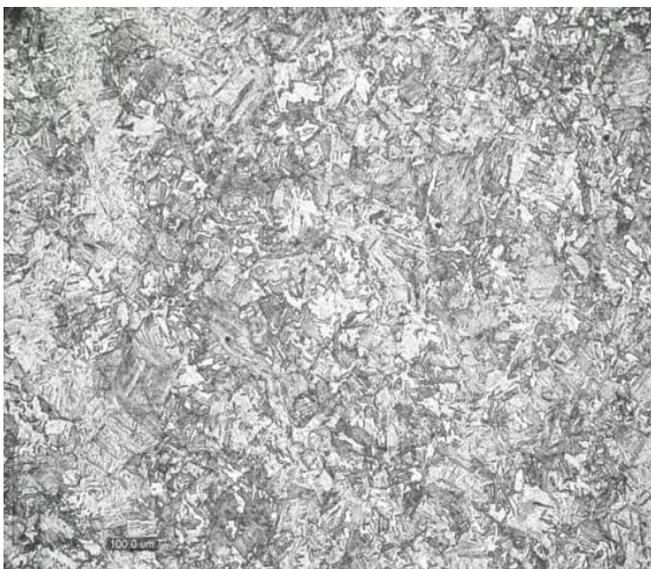
The microstructure of the broken shackle chain (Fig. 4) consisted of ferrite, and tempered martensite, and indicated that the shackle chain had experienced heat treatment process. The AISI 4140 steel usually had a high hardenability, strength, and wear resistance. The elements of Cr and Mo are generally known as carbide formers as well as ferrite stabilizers, while Si tends to improve high temperature wear resistance of the steel [9, 10].

Fig. 4 Microstructure of the broken shackle chain.

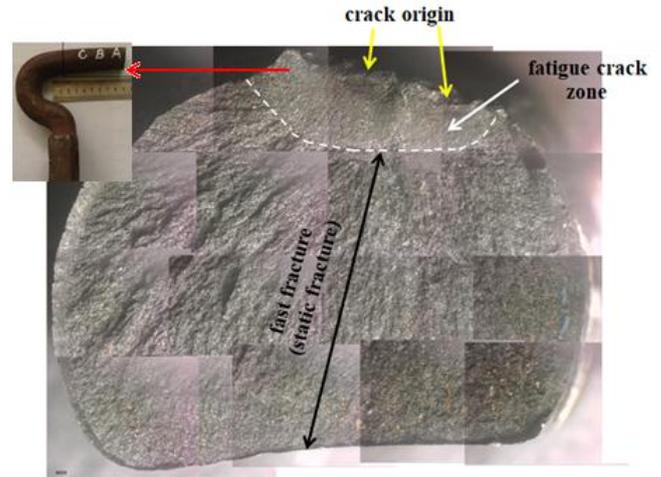
Fig.5 Optical image of a fracture surface collage made by superposition of specific areas and the white dashed line indicate the distinct fracture zones (the insert picture in the top left corner indicated by red arrow is the location of the crack origin of sample A in Fig 3.).

Fig. 5 showed the information of the location of crack origin, and the fracture surface morphology. Two locations of initial crack were observed and beach marks showing fatigue crack propagation were seen in the crown region close to the surface outer. There was a clear distinction between smooth fatigue zone and final overload. The fatigue zone was smaller than the static fracture zone.

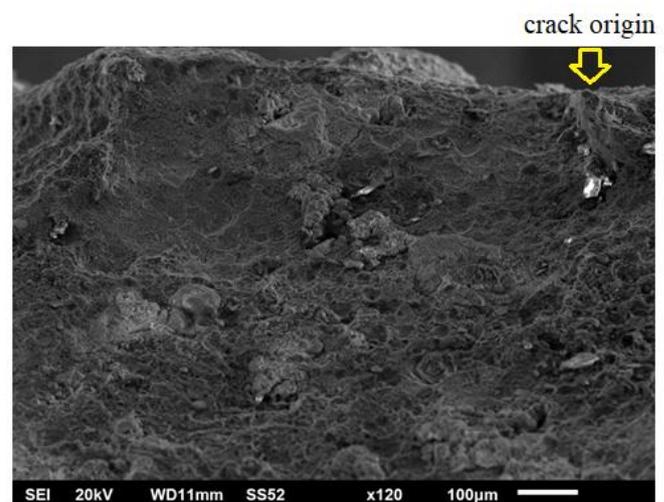
Fig.6 Secondary electron image on fatigue crack zone showing a fairly flat surface with beachmarks and crack of origin.

SEM observation shown in Fig. 6 indicated that the fracture surface was smooth and the location of crack origins was close to outer surface of the crown area of the shackle chain. Fatigue cracks remained fairly flat in appearance even, but they had a shape similar to 'cottage cheese' which was slightly rippled [11].

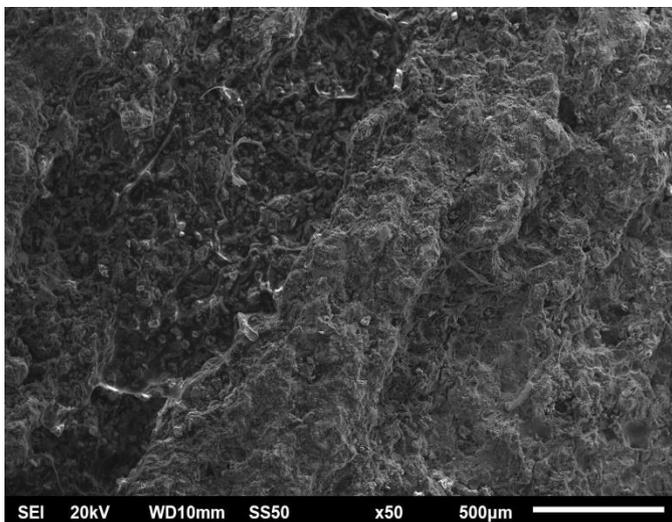
Fig. 7 Secondary electron image on the static fracture zone.

Fig 7 showed SEM image on static propagation with brittle fracture characteristic, which was indicated by transgranular crack. The small fatigue zone and the transgranular mode in static area exhibited that the material of shackle chain was brittle.

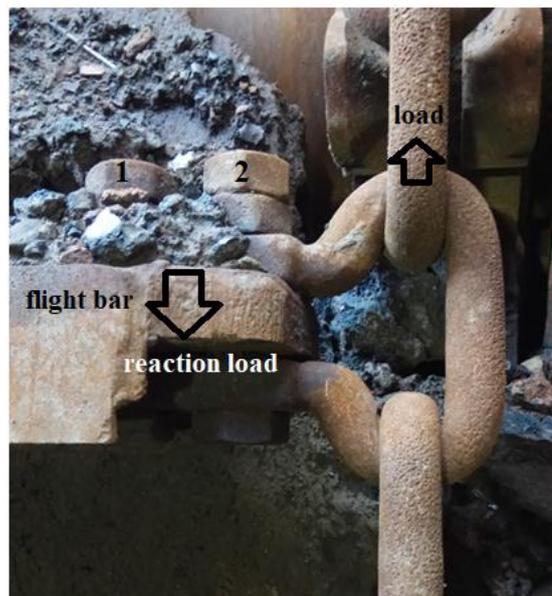
Fig. 8 Load and reaction load which occurred when shackle chain was in use and the shackle chain was locked down to the flight bar by two bolts (number 1 and 2).

Fig.8 showed the load and reaction load during the shackle chain was operated. The shackle chain at the bow (chain link) was connected to the chain and at the upper / lower body was connected with a "locked" flight bar using a configuration of 2 pairs of bolt and nut (marked with "1" and "2" in Fig.8).

In a normal condition, the connection system (bolt and nut) that integrated the shackle chain with the flight bar must be tight and the load carried by the flight bar would be fully restrained by the chain link (load reaction). We expected no dynamic load acting on the shackle chain. On the other hand, if the connection system (bolt and nut) did not work well, for example due to wear or corrosion, it would cause an increase in the gap (clearance) in the connection system (bolt 1 and 2). This caused a relative force between the upper shackle body and the lower shackle body resulting in the moment on the crown so that the load reaction was not fully held by the chain link / bow.
