Gap Analysis Between Macondo Deep Water Horizon Drilling Blowout With Regulations And Industry Standards & Codes

Abstract

This paper presents case study based GAP analysis between technical regulations (namely, recommended practices, guidelines, Industry standards and codes that existed prior to the blowout) and the implemented design /operation in Macondo well.

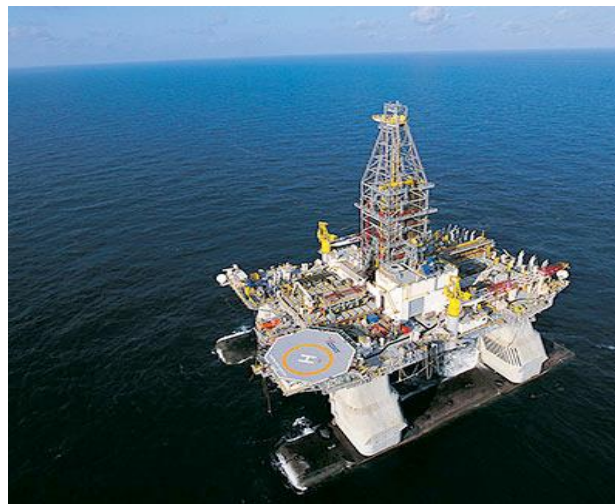
Figure 1b: Deepwater Horizon semisubmersible rig[1]

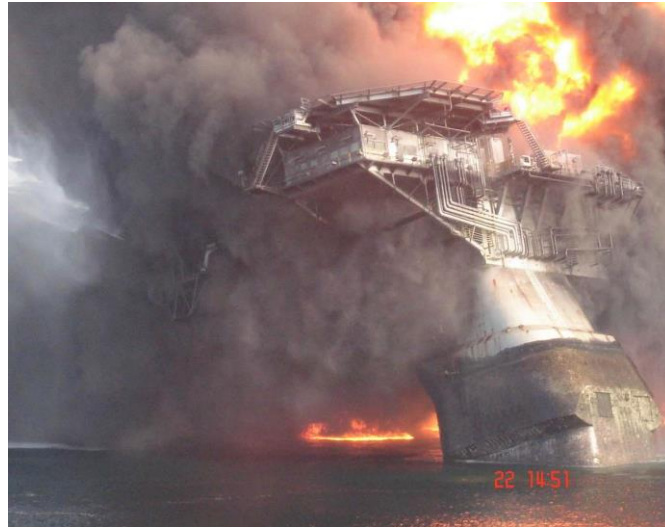
On April 20, 2010, a mile beneath the ocean disaster struck following a series of events in the world's biggest blowout (Figure 1c), causing 11 casualties and 17 were greatly injured. Thirty six hours later the fire and explosion on the rig caused the rig to sink to the sea floor. A huge amount of hydrocarbon spilled from the reservoir into the ocean, which lasted for 87 days and damaged fauna and flora (Figure 1d). The environmental impact of the blowout in the Gulf of Mexico is still being discussed and researched. The incident also traumatized the livelihood of many people.

Figure 1c: Macondo Well Blowout [1]

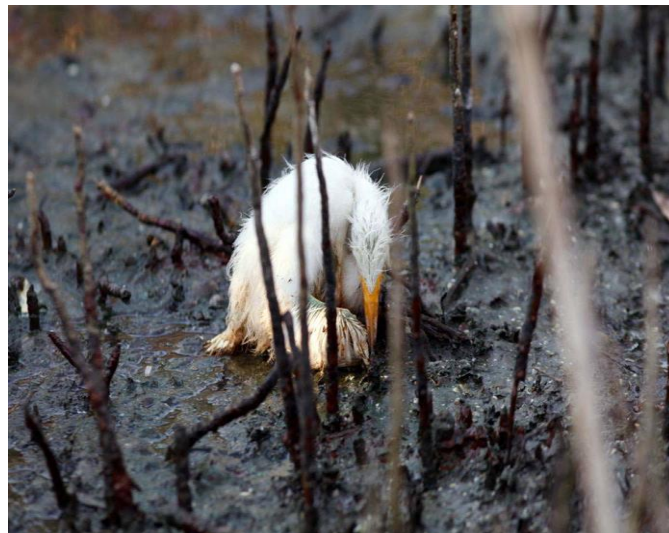
Figure 1d: Environmental impacts on fauna and flora[1]
