Condition Assessment of Busbar Insulation System Subjected to Hazardous Fire Using Dielectric Technique

^{1,2,3,4,5}Central Power Research Institute, Bangalore.

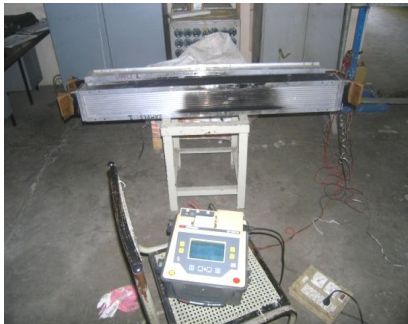
Fig. 1: Test setup of IR & PI measurement

The insulation resistance has been determined by means of insulation resistance which is shown in the Fig 1 at constant DC voltage of 500V. The experimental setup has been shown in Fig 2. The dielectric dissipation factor also called as tandelta is measured with standard bridge circuit at voltage of 1kV. In this test both capacitance and tandelta have been measured at 500V & 1kV for each phase of the busduct with respect to insulation system of enclosure of the busduct. The experimental setup has been shown in Fig 3.

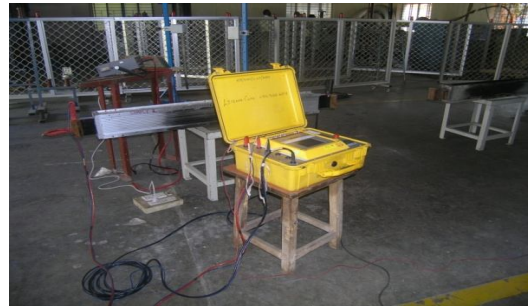
Fig. 4: Test setup for - Conductor resistance measurement

The dielectric measurements are carried out on a fresh model of busduct. The conductor resistance has been measured for all the conductors of the busduct using micro ohm meter. The experimental setup has been shown in Fig 4.

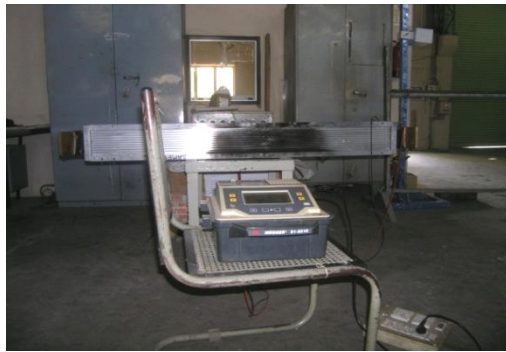
Fig. 2: Test setup of IR & PI measurement

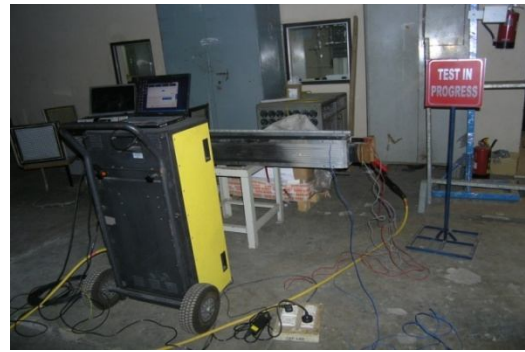
Fig. 3: Test setup of Capacitance & $\tan\delta$ measurement

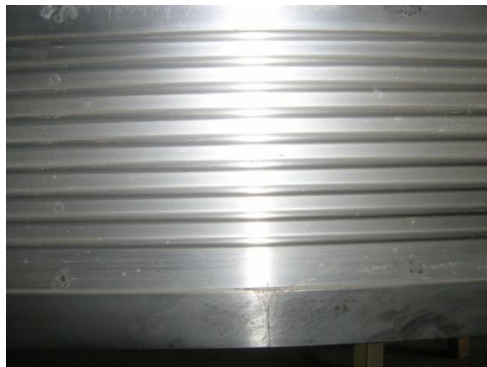
Fig. 5: Busduct before Fire Survival test

The new busduct with all bus conductors, neutral and ground plate with clean surface is shown in fig 5 & 6. The busduct has been subjected to fire survival test [1,4]. The procedure for conducting the test has been adopted as per international specification. The experimental result after the fire survival test is shown in fig 7 & 8.

The two models of samples have been subjected to fire survival test has described in previous paragraphs. The sample 2 model busduct has shown heavy carbon deposit on the envelope of the enclosure as well as deposits of carbon on conductor surfaces of the bus, breakdown of insulation. The fig 5 shows the carbon deposits formed on the busduct. Fig 8 depicts the terminations of the busducts with insulation damage. Fig 7 shows the terminal ends of busducts which as survived from fire resistant test, the dielectric parameters also supports the condition of the busduct. In the case of sample 2 busduct model, there is enormous increase of dielectric dissipation factor to the extent of 10 to 15% of the magnitude. The insulation resistance values of the busduct showed abnormal low values of few mega ohms compared to initial healthy condition of sound insulation of order of a few giga ohms, this conclusively proves the extensive damage of insulation, high concentration of contaminants which require immediate remedial measurement for restoration of electrical network with proper, healthy well insulated busduct.

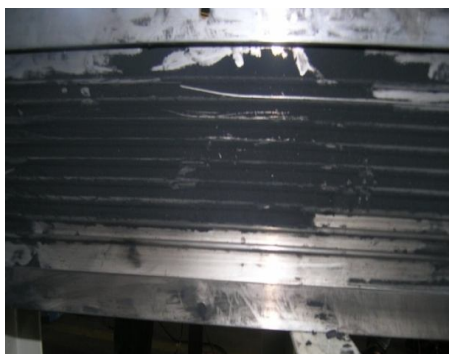
Fig. 7: Busduct after Fire Survival Test

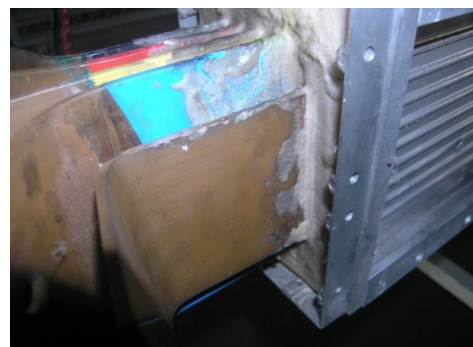
Fig. 8: The terminal ends of busduct model with dielectric envelop after fire survival test

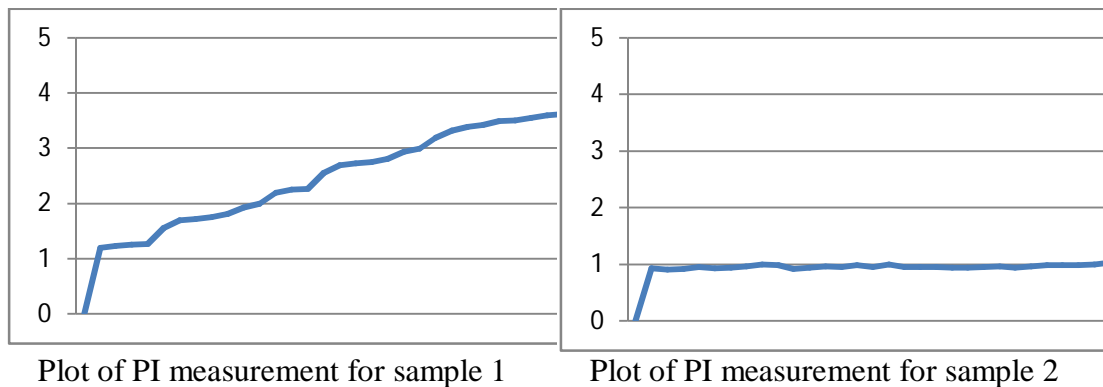
Fig. 9: The Oscillogram generated for polarisation Index test for busduct model.
