Refurbishment of Alkhua Mosque: Using environmental Design principles

Ali Alzaed

Assoc. Professor, Architectural Eng. Dept.,
Faculty of Engineering, Taif University, Saudi Arabia.

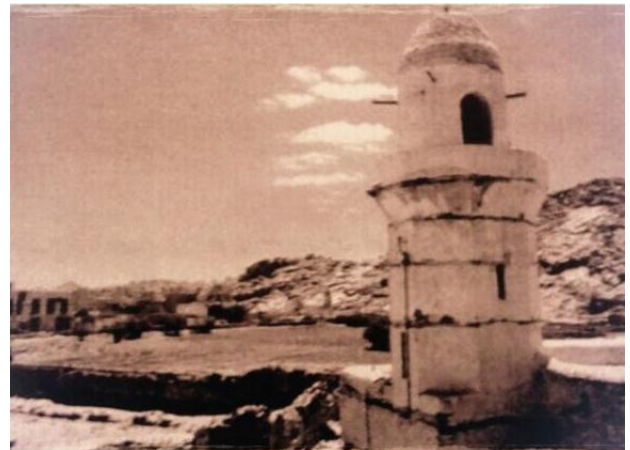
Fig. 1. The minaret of Kubzaa mosque [1]

Kubzaa mosque is located in Valley Wej, its tall is 12 m and its shape are square. This mosque is surrounded by bowl which exposed from the eastern and southern sides, and the place shape, where the funeral prayer, is square, too, its span is 9m². The Mihrab is located in the west side. The minaret is located in the eastern corner of the mosque, and is made up of three sections, the bottom square, the centre octagon, the upper rounder and ends with semi-dome structure, model similar to minarets that were built in Egypt and Yemen in the seventh Hijri century.

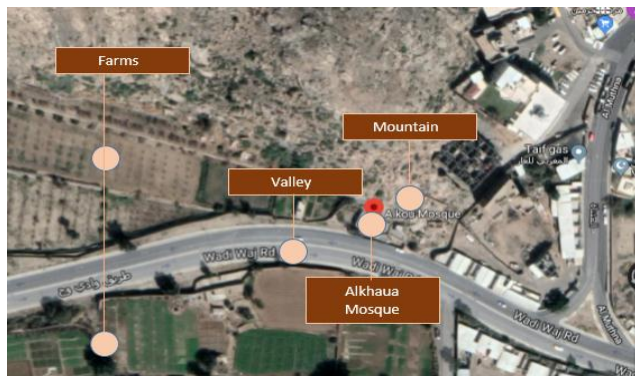
Fig. 3. Site environmental analysis

In terms of site location, this mosque respects the site topography through many measurements as appeared in the following photo. One of its respective was built on different levels as well as respects the gradients of the nearby mountain. Site selection and dealing with the topography was one of the main pillars that considered by the ancestors of Zhaoxing Village with harmony on the both side of the flat river valley. It was structured to be inhabited [6]. This show to what extends the essential of consideration the surrounding area during the building construction as well a take the advantage of the available natural factors.

This mosque is closed also to natural farms which are kind of unique environment that include both Farms and Mountain and located on valley Waj as shown on the following photos of site as shown in Fig. 3.

Using natural material is one of the environmental building attributes. This is appeared on the mosque walls where used stone and mud one the one hand. On the other hand, it was used wood for roof with cover of the mud. These gives a good thermal comfort during the winter time where the environment degree achieved 14 degree during winter time as referred on [7].

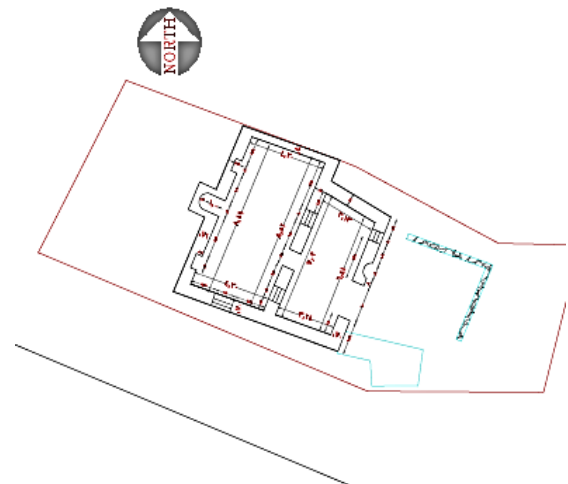
Fig. 4. Ground floor plan

One of the main documentation attributes was drawing the elevations and the plan of the mosques illustrated in Fig. 4, 5, 6 and 7. In addition to that, it has been documented some of the mosque details such as Fig. 8. It is also recorded its sizes and dimensions. This was through using AutoCAD Software. The shape of the mosque is an irregular plan.

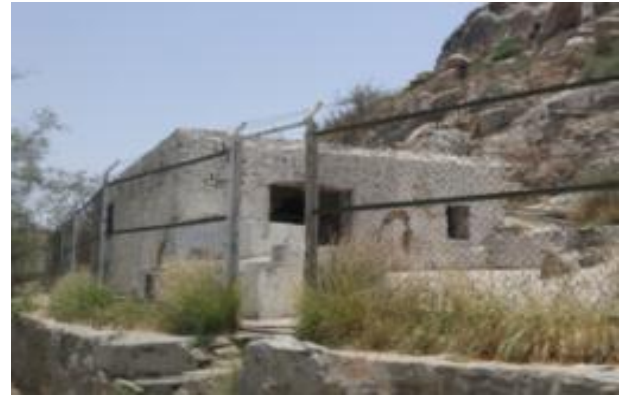
Fig. 12. Outside perspective

For the site documentation and building was snapped different photos which shows Fig. 12, 13 and 14, which shows its perspectives, elevations and the previous restoration attempts. The white paint was developed after being subjected to an attempted burn and must be taken into account when developing the restoration plan.

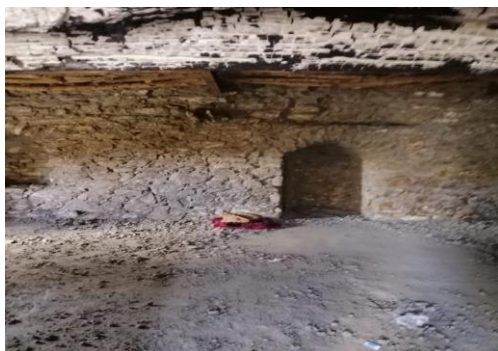
Fig. 15. Abrade wall during the refurbishment

Restoration of the outer and inner cover of the mosque by abrades the previous layers refurbishment such as the old roof, outside paint and some interior renovation. This was for two reasons as follow: One of the reasons is that the previous restoration was performed in a non-professional manner. As a result of the previous restoration the features of the mosque were changed. In addition to that, the refurbishment is considered the environmental issues in terms of respecting the location topography, and using the local material.

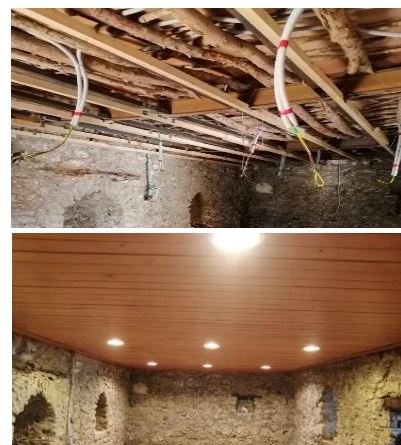
Fig. 16. Roof before and After Refurbishment

The roof was replaced because it is one of the building elements that was previously affected by the fire. It was using three layers concrete, wood board and Armstrong ceiling aluminium. These materials were selected in terms of the local material and simulate the previous style.

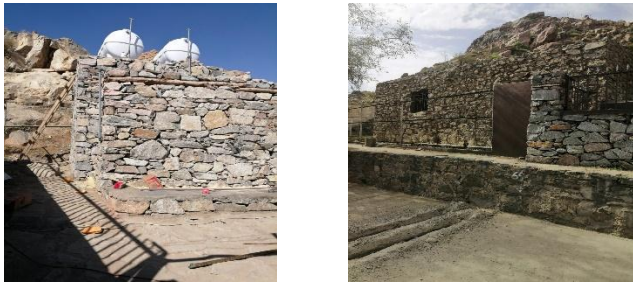
Fig. 17. The new construction surrounding wall, bathrooms and flagstones

The surrounding area of the mosque has been developed to achieve the security and the basic needs. In terms of the security, this was through building the surrounding wall. In terms of the basic needs, there was not a bathroom in the site. Even though, one of the main conditions to pray is to perform

ablution. For this reason, the availability of the bathrooms is an imperative. It is considered through using the local environmental material.

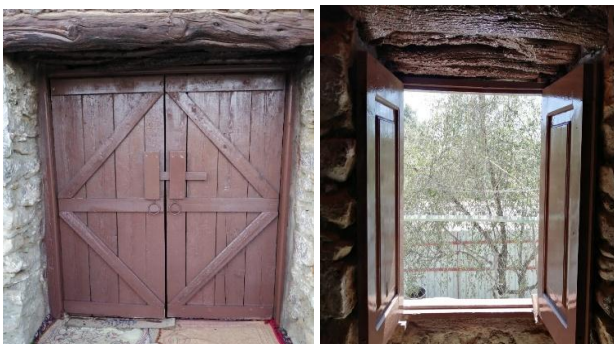
Fig. 19. The new door and window

There were no doors or windows but openings to the surrounding area. For this reason, after the rehabilitation of the building from both sides inside and outside, the door and window were installed of local wood which lead to meet the environmental conditions during the refurbishment.
