Installation Situation of Tactile Walking Surface Indicators in Israel

MIZUNO Tomomi¹, TOKUDA Kastumi¹

¹Faculty of Medicine, University of Tsukuba, Japan.

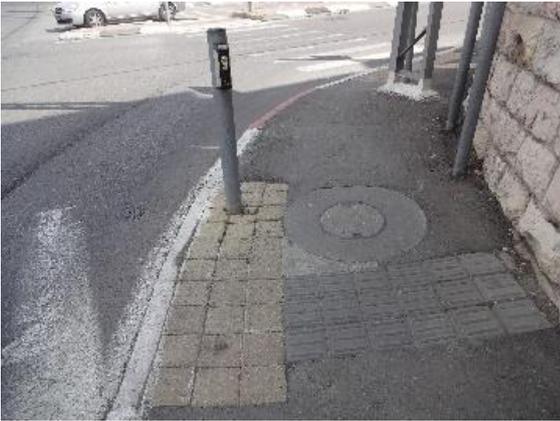
Picture 1: In Jerusalem

Three rows of warning blocks in the size of 15cm square were set up in front of the crosswalk. The pole for the traffic light push button was arranged on top of warning blocks.

There were 2 to 3 lines of warning blocks installed in front of a cross walk (Picture 1). From the warning blocks, 2 to 3 lines of directional blocks were installed to the center of the side walk or on the other edge. It means that when people with visual difficulties find directional blocks while walking, following the directional blocks on the roadside will lead them to the cross walk. Similar to the installation in Japan, directional blocks are indicating the direction of the cross walk (Picture 2).

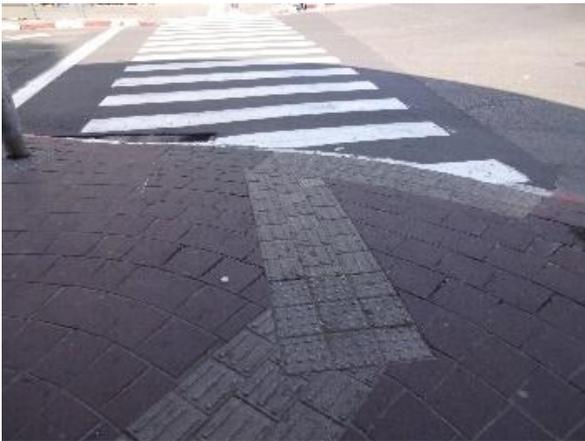
Picture 2: In Jerusalem

Directional blocks in front of the crosswalk were set up to indicate the direction of the crosswalk. The way they were set up was appropriate.

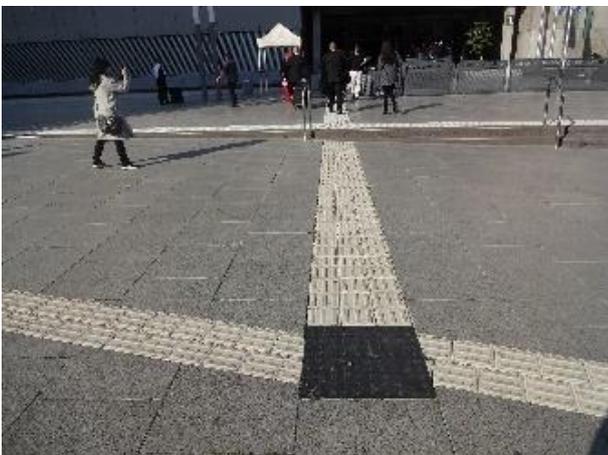
Picture 3: In Tel Aviv

White directional blocks were set up in front of public facilities. Black warning blocks were set up on the intersection of the directional blocks.

Directional blocks were installed only in front of the cross walk and there were not many installed as they were in Japan. It means that directional blocks in Israel do not have the function of leading people with visual difficulties. Although it is rare, there were blocks that have the function of guidance in front of public facilities (Picture 3).

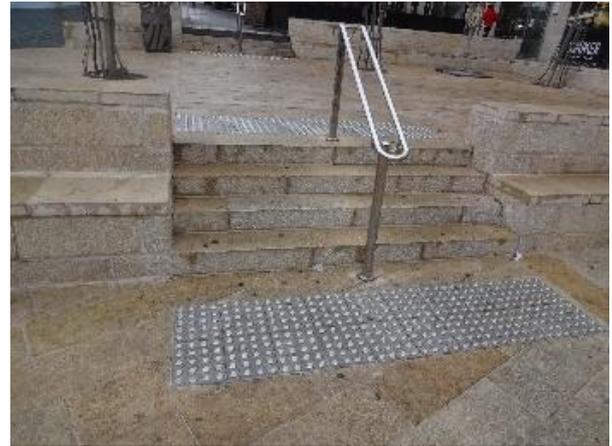
Picture 4: In Tel Aviv

Warning blocks were set up on the top and the bottom of the stairs at the entrance of the park in Tel Aviv. However, there were rarely any set up at the stairs in Israel.

Although there were few areas, some stairs and escalators had warning blocks installed at the beginning and the end (Picture 4, 5). Also, directional blocks were installed at the market (Picture 6) and shopping mall (Picture 7) in Tel Aviv. They both lead to the elevator.

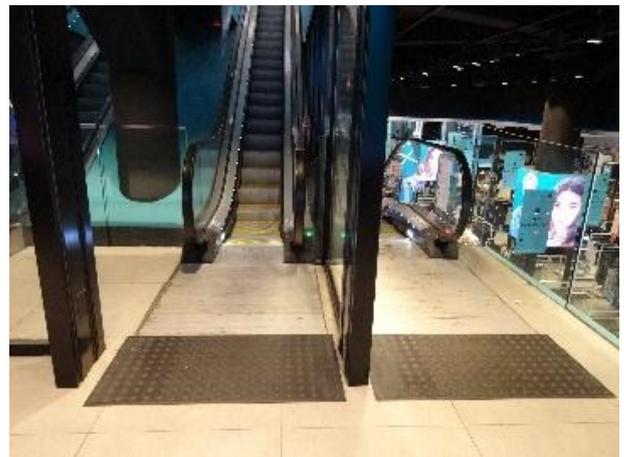
Picture 5: In Tel Aviv

Warning blocks were set up at the beginning and the end of escalator in the shopping mall in Tel Aviv. However, it is too far from the escalator.

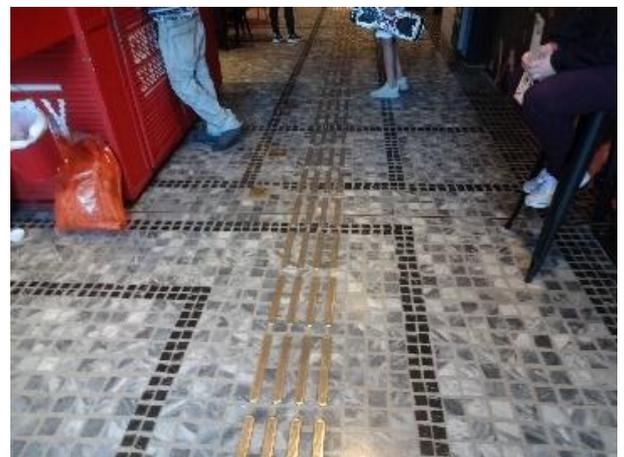
Picture 6: In Tel Aviv

Directional blocks were set up at the local market.

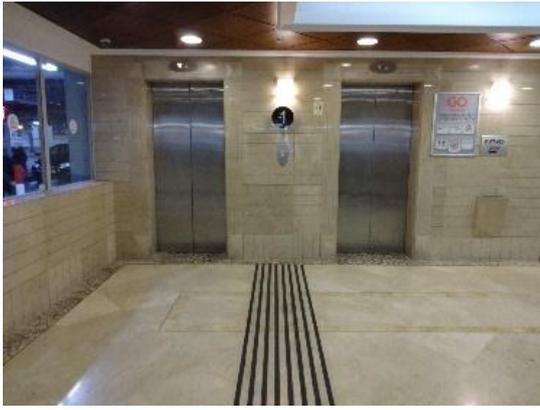
Picture 7: In Tel Aviv

Directional blocks set up in the shopping mall in Tel Aviv was 60cm in width.

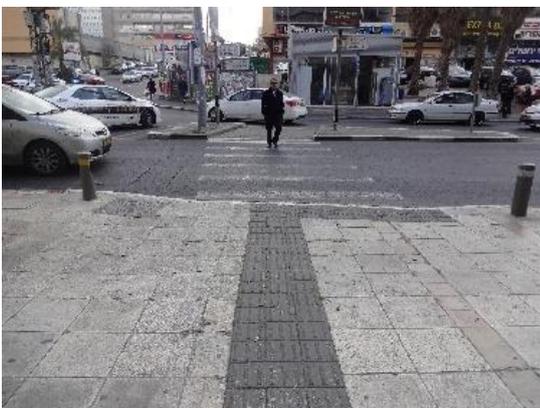
Picture 8: In Jerusalem

There were some areas where many sidewalks had warning blocks set up partway across the crosswalk instead of the whole way across so wheelchairs and strollers can go. The way they were set up was appropriate.

Warning blocks were not always installed on the whole width of the cross walk (Picture 8). This installation method is different from Japan's. It means that they were installed in a way that bicycles, buggies, cars do not have to go over the warning blocks when they cross the cross walk.

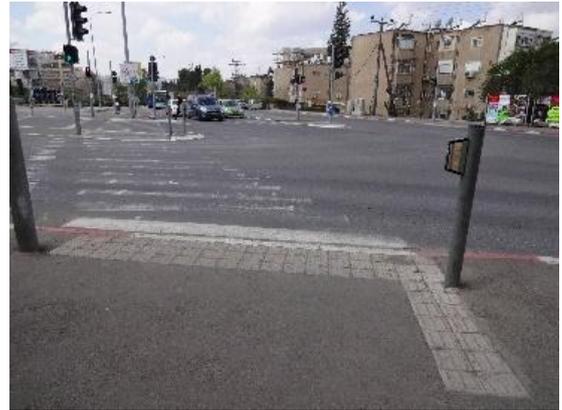
Picture 9: In Tel Aviv

Push buttons for people with visual difficulties were often set up on the right side of the warning blocks in front of a crosswalk.

There were some areas where push button and sound signal for people with visual difficulties were installed at the cross walk (Picture 9). There were many of them installed in the center of Jerusalem and Tel Aviv. The device shown in Picture 10 has a button on the front and when the pedestrian sign turns green, the arrow on the top vibrates and make clicking sound. As the click rhythm become quicker, it is closer to turning red.

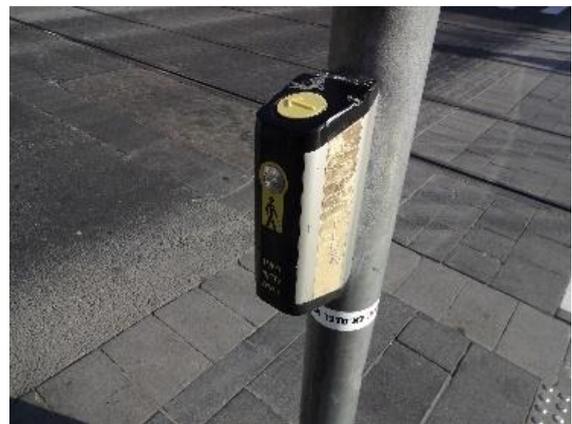
Picture 10: In Tel Aviv

Push button for people with visual difficulties. When the pedestrian light turns green, the arrow shaped bump on the top vibrates or make clicking noise.

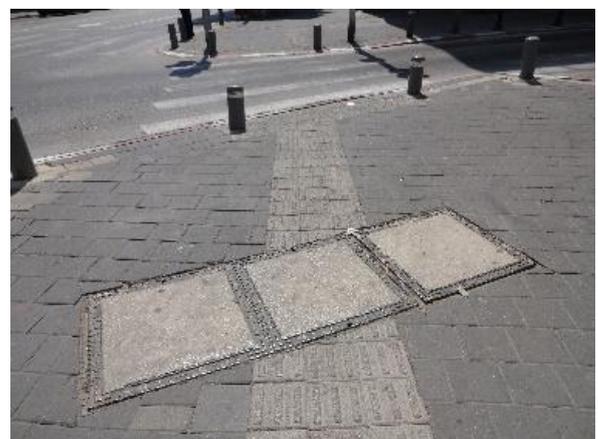
Picture 11: In Tel Aviv

Directional blocks were not set up on a utility access hole.

It is clear that the function of tactile walking surface indicators declines unless they are installed on top of a manhole. In Japan, tactile walking surface indicators are installed on top of most manholes. There were areas in Tel Aviv where blocks were not installed on a fairly large manhole (Picture 11). On the other hand, warning blocks made with metal plate was put on a manhole in Jerusalem (Picture 12).

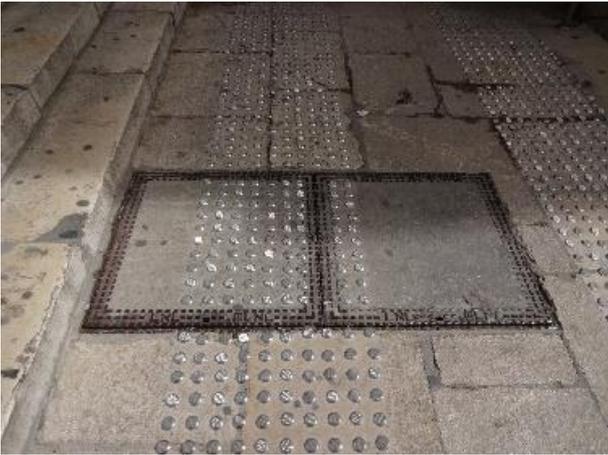
Picture 12: In Jerusalem

Warning blocks were set up on top of a utility access hole. Whether they are set up on a utility access hole or not seemed to be undetermined.

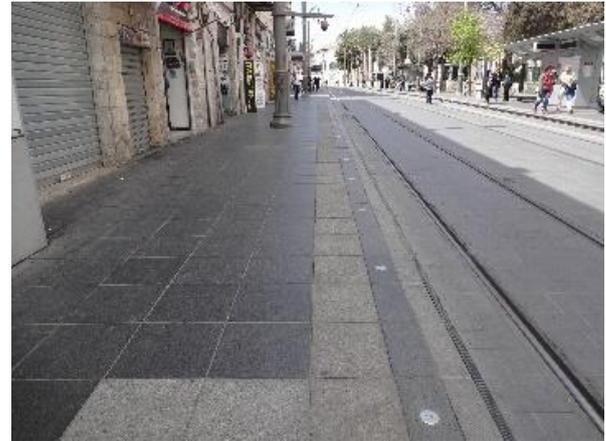
Picture 13: In Jerusalem

Warning blocks were not set up on the platform of a streetcar. However, tiles with bumpy and rough surface were set up in the area where warning blocks were normally set up.

Unique tiles were installed on the platform of a street car stations in Jerusalem. The platform of a street car station is long (Picture 13). Along the long length, coarse rocks, unlike the dot shaped blocks as seen in Japan, were installed at 20cm from the edge of the platform as warning blocks (Picture 14). These rocks were used only on the platform of the street car stations in Jerusalem. Also, directional blocks were installed on the platform to indicate the street car doors (Picture 15). Directional blocks are not installed at all the doors, but one door per cart.

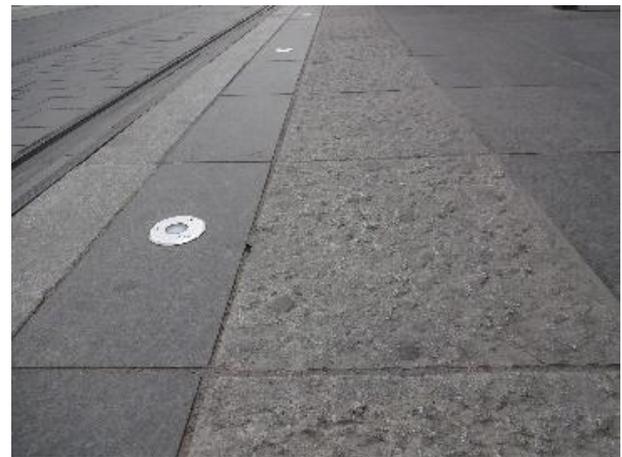
Picture14: In Jerusalem

Rough tile on the platform. They were set up instead of warning blocks.

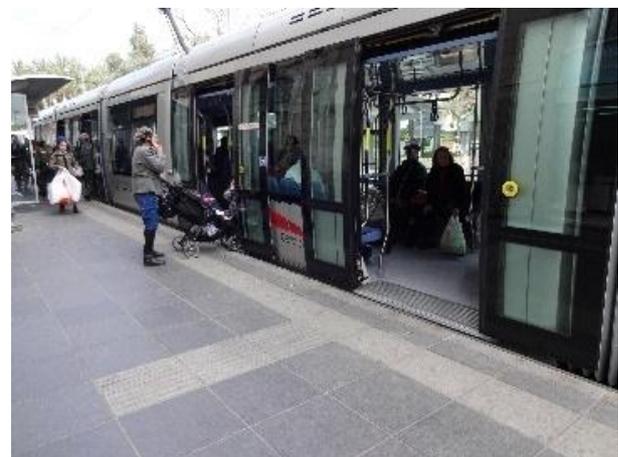
Picture 15: In Jerusalem

Directional blocks were set up on the platform to show where the doors of the train are.

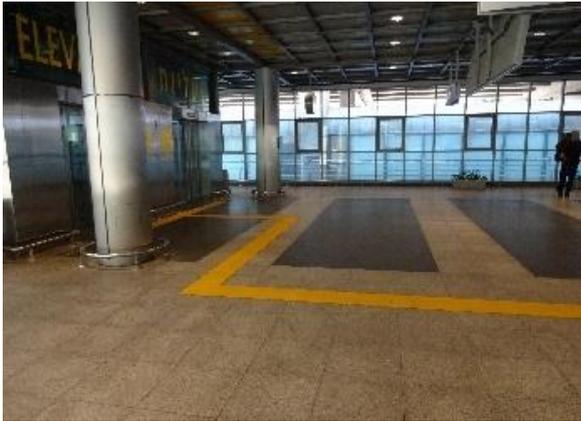
Picture 16: In Tel Aviv

Blocks in the railway station. There were no bumps on the surface and it was a sheet with a rough surface.

There were unique directional blocks in the railway station of Tel Aviv. Sheets with different texture than the tiles around with no bumps on the surface were installed as warning blocks (Picture 16). They were black or yellow sheets with rough surface with a lot of friction. There were dot shaped blocks installed as warning blocks in the intersection of directional blocks (Picture 17).

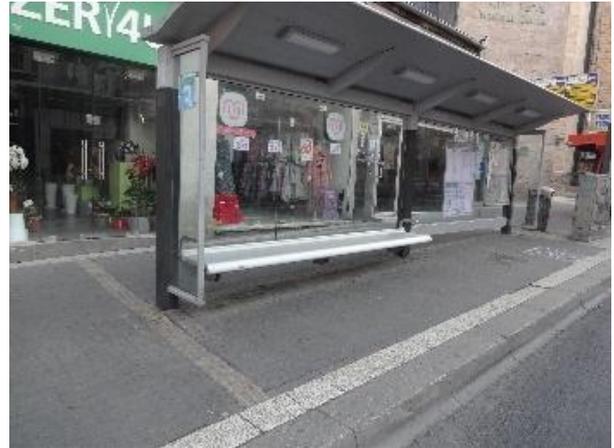
Picture 19: In Jerusalem

Directional blocks with the width of 20cm were set up on the sidewalk of a bus stop and warning blocks were set up on the road side in Jerusalem.

Unique tactile walking surface indicators were installed at the bus stations in Jerusalem. 20cm directional blocks were installed across on the whole length of the side walk by the bus stop (Picture 19, 20). It was not at all the bus stops in Jerusalem, but most bus stops in the city center had these blocks installed.

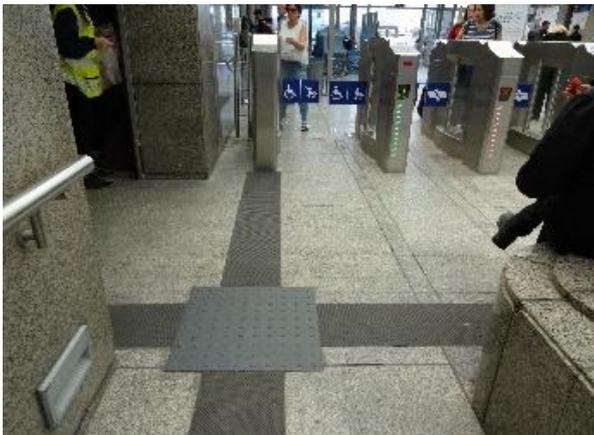
Picture 17: In Tel Aviv

Blocks in the railway station. The direction was given with the sheet with rough surface and blocks with round bumps were used for the intersection.

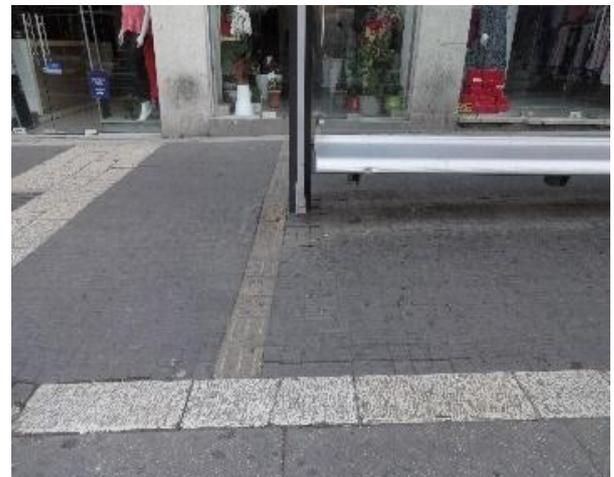
Picture 20: In Jerusalem

A bus stop

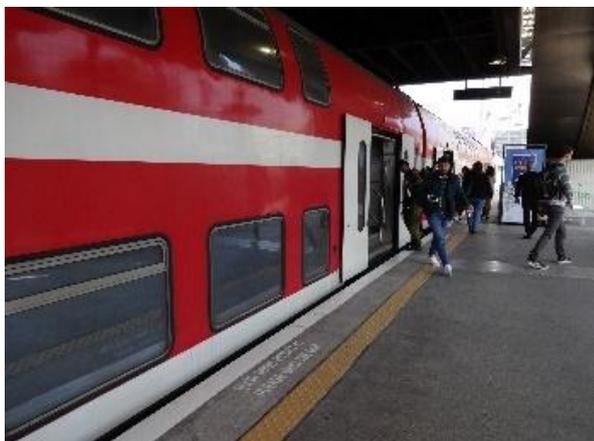
Picture 18: In Tel Aviv

Platform of a railway station. Warning blocks with the width of 20cm were set up 60cm from the edge of the platform. There was no landmark to show the location of the doors.

On the platform of a railway station, 20cm width warning blocks were installed at 60cm from the edge of the platform. There was no landmark that indicated the location of the train door (Picture 18).

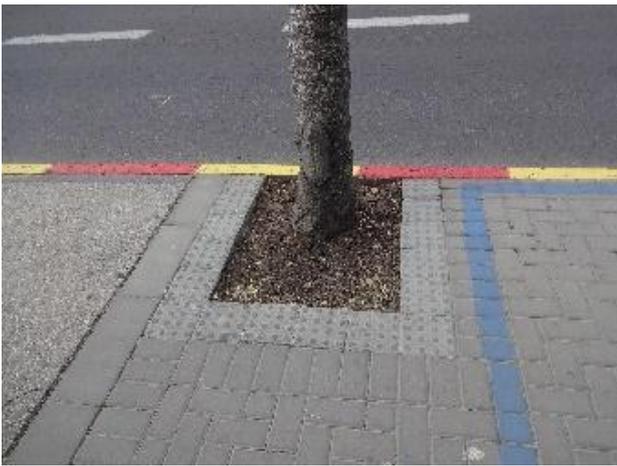
Picture 21: In Jerusalem

A tree planted on a sidewalk in the center of Jerusalem. Warning blocks with the width of 20cm were set up around it. The way they were set up was unnecessary.

There were tactile walking surface indicators that was used for other than its purpose. There were 20cm width dot shaped blocks at the edge of the plantation on the side walk in the center of Jerusalem (Picture 21). There were many plantations but they were installed only here so we evaluated that it is not for warning. Also, there were 60cm width warning block in the children's park in Tel Aviv (Picture 22). At the direction of warning blocks, there were swings so if you go beyond the block, there is a danger of bumping into a swing that a child is on. However, it was the only place where tactile walking surface indicators were installed in this park so they were not for people with visual difficulties but installed for general people to warn the dangerous zone.

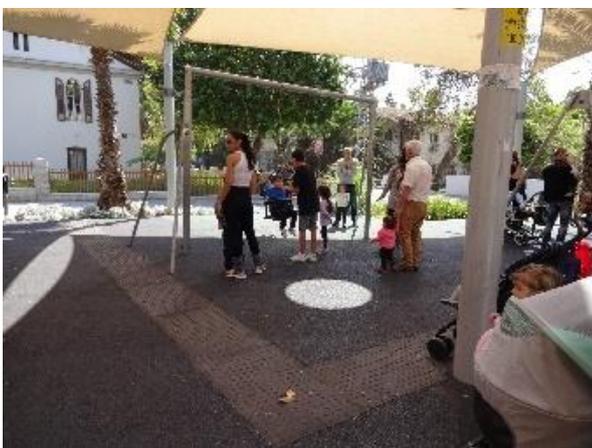
Picture 22: In Tel Aviv

Warning blocks with the width of 60cm were set up around the swing in a children's park.
