Decrease in the Transport Process Indicators Due To Wear of the Elements of the Power Unit of the Truck

Keywords: truck efficiency, transport process, carrying capacity, power unit, technical condition of a truck, power characteristics

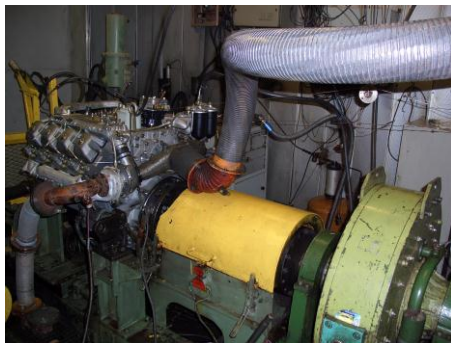
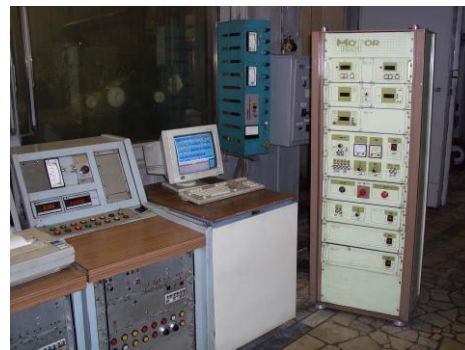
Figure 3. Stand engine test

Upgraded repaired turbochargers (10 pcs.) were compared with serial turbochargers installed in series on the engine on the test bench of the AVL engine plant (Fig. 3).

To measure the required parameters, the stand is equipped with the necessary measuring equipment, corresponding in terms of measurement accuracy to the conditions for the manufacturer's plant.

Comparative bench tests of the KamAZ-740.11-240 engine with TKR7N-1 turbochargers were carried out during operation in comparison with the parameters after repair with the modernization of the bearing assembly. The external speed characteristics of the engine were filmed. Comparative motor tests were carried out in versions equipped with serial turbochargers and repaired turbochargers with modernized bearing assemblies in terms of speed characteristics.

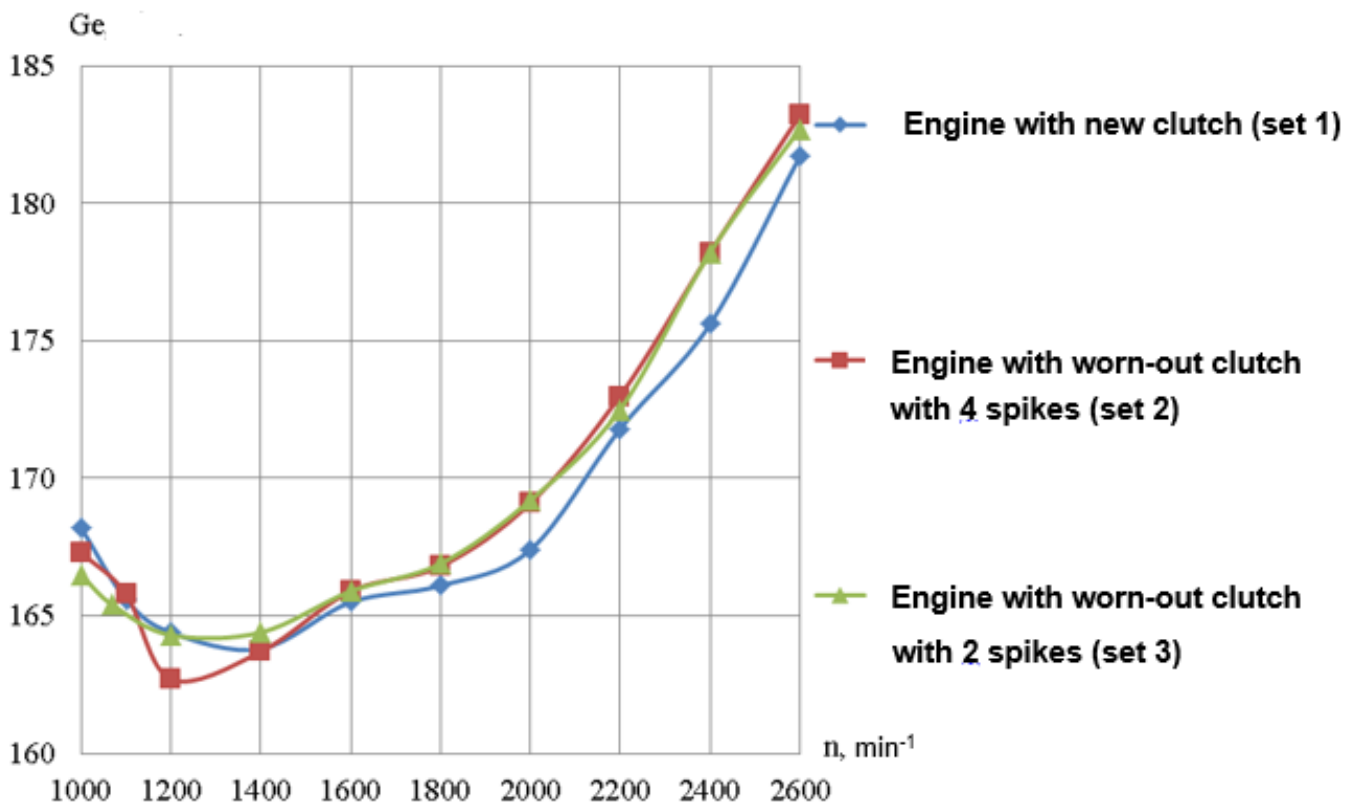
Figure 3. Effective specific fuel consumption of an engine with different clutch sets by external speed characteristic

At a crankshaft speed over 1200 min⁻¹ (Fig. 3) with practically identical loads, a deterioration in the effective power and specific fuel consumption of the engine was revealed.

During operation, when the contact surfaces of the “thorn-groove” interface are worn out, the driving discs are displaced relative to the flywheel, their centering is disturbed, and this, in turn, leads to an increase in the imbalance in the clutch unit, having a negative effect on the operation of the engine and its reliability [9]. At a crankshaft speed of 2600 min⁻¹, a centrifugal force acts on the drive clutch disc (whose mass is 13.2 kg), which reaches 400 kg · s, which leads to an

imbalance and vibration of the entire vehicle. Under such conditions, part of the engine's energy leaves the clutch for secondary processes of excitation of vibrations of the vehicle elements, thereby losing useful power.

1. Wear of the clutch elements causes the power and economic indicators of the engine to decrease, which is caused by the formation of an imbalance and the transfer of part of the engine power to secondary processes that occur in the clutch mechanism in the form of vibration and shaking. In all modes, an increase in specific fuel consumption and a decrease in effective engine power are noted.
