# Masonry Walls Retrofitting with Eco-Concrete Bricks in Tidal Flooding Prone Area

Durability of concrete masonry wall in marine environment is a big issue that related to the deterioration of the structure exposed to seawater. Therefore, proper retrofitting should be done effectively to gain high durability of the structure. This research aims to: (1) developed eco-concrete bricks that were implemented to retrofit masonry wall in tidal prone area; and (2) to investigate durability as well as compressive strength development of concrete bricks produced in the laboratory and applied to masonry wall for 14 months. Research activities consisted of: (1) Experimental activities of concrete bricks mix design optimizing, production, and compressive strength test of concrete brick specimens; (2) Field application which consisted of masonry wall retrofitting by eco-concrete bricks, and (3) Core Drill of concrete masonry wall and compressive strength test of the Core Drill specimens. The concrete bricks made of natural polymer such as *Moringa oleifera*, *Gracilaria Sp.*, and also honey. Masonry walls were built in Sriwulan village as tidal prone area and in Pucang Gading as dry and lowland

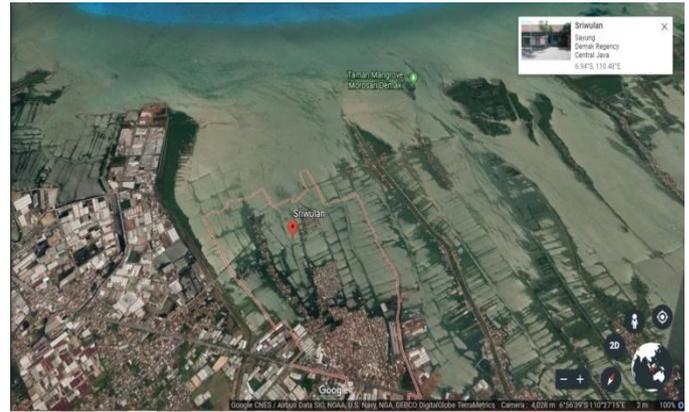
**Fig 1.** The map of Sriwulan Village in Sayung Sub-district, Demak Regency, Central Java, Indonesia (by Google Earth)

Site for masonry wall construction retrofitting was in Sriwulan village in Sayung sub-district, and also Pucang Gading Village in Batusari sub-district, both were in Demak Regency, Central Java, Indonesia. Sriwulan village (Fig 1) is located in coastal area of Java Sea which is also tidal flooding prone area and Pucang Gading village (Fig 2) is dry and lowland area.

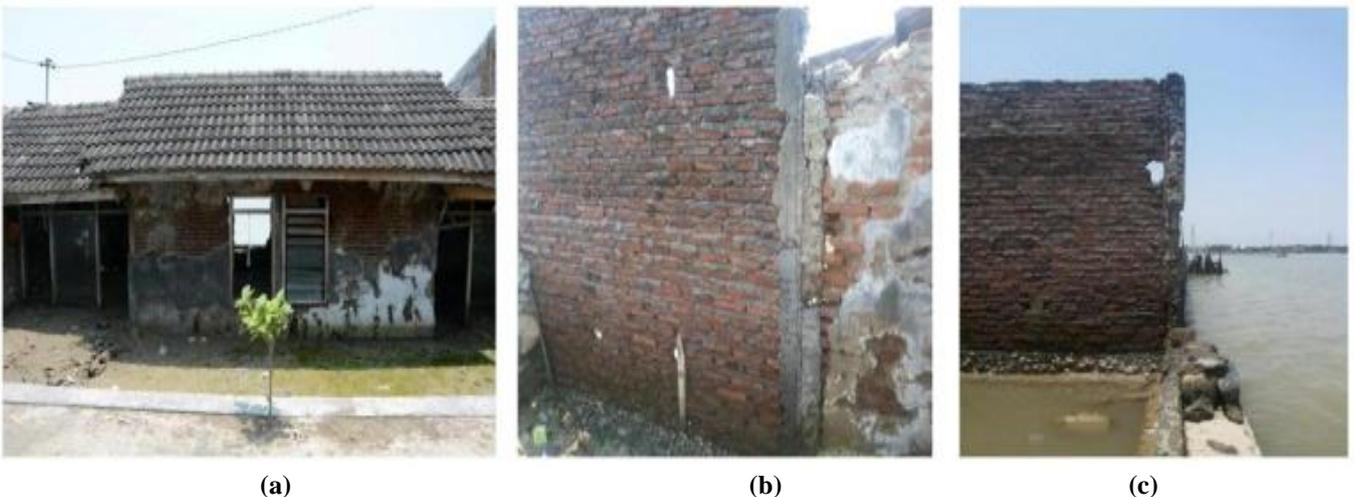
**Fig 3.** Situation of the site: (a) a house that directly adjacent to the sea; (b) the broken part of clay brick masonry wall; (c) the area outside the house that submerged by seawater and routine tidal flooding

Sriwulan village always be influenced by tidal flooding for more than two decades. This village was located next to the sea and very flat with altitude of 1-3 m of sea level. The tidal flooding continuously submerged Sriwulan village very badly, from only 25 cm in 2004 until 20-50 cm in 2018 [1], and even 50-150 cm as the worst happened on December 1, 2017. This situation was the opposite to Pucang Gading which is dry and clear lowland area with no tidal flooding. A house in Sriwulan village with broken clay brick masonry wall and that hardly submerged with seawater and also routine tidal

Field application was conducted in the end of 2016 after the optimum mix design and dimension of specimens have been found by previous laboratory test. The composition of K3-B was produced as concrete bricks for masonry wall retrofitting as shown by Fig 3b. After that, the broken part was selected to be retrofitted with procedure shown by Fig 9. The broken part of masonry wall of 50 cm x 50 cm in square was removed and then filled by concrete bricks (K3-B) and covered by mortar mix (Fig. 9).

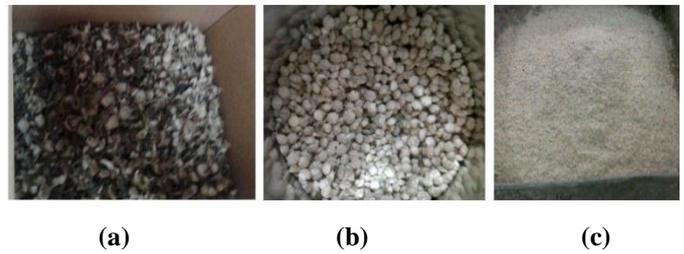
**Fig 6. Raw *Moringa oleifera***  
 (1) raw material; (2) seeds without skin; (3) powder

Specimen material consisted of cement, sand, water, and honey (liquid form), and also natural polymers that are *Gracilaria Sp.* powder and *Moringa oleifera* powder. This research used *Gracilaria Sp.* powder that was manufactured product of gelatine powder (Fig 5) while *Moringa oleifera* powder was made by grinding raw *Moringa oleifera* seeds (Fig 6). The natural polymers added in during concrete mixing with cement, sand, and water.

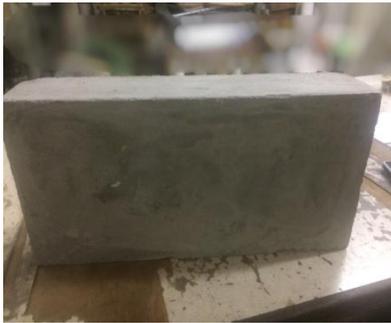
**Fig 7.** Concrete brick specimen

All specimens, (Fig 7) described by Table 2 (Pe-Experiment) and Table 3 (Main Experiment) were cured and tested in compressive strength based on SNI (Indonesian National Standard) No. 03-03449-1989 on “Concrete Brick for Masonry Wall”. Compressive strength test was conducted by Compression Machine CO-325.4 (Fig 8) for concrete brick

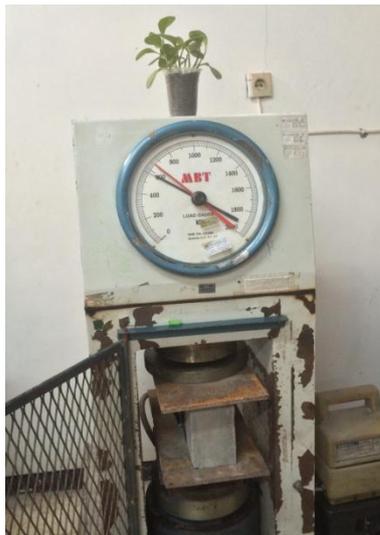
**Fig 8.** Set up specimen and Compressive Strength Test Machine

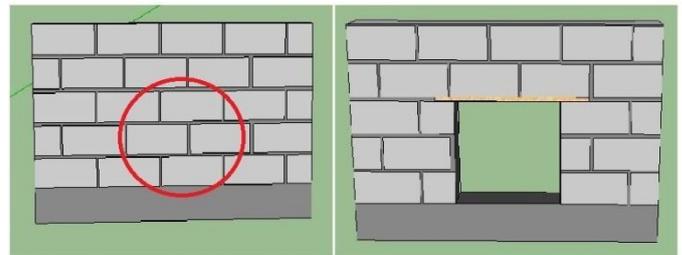
**Fig 8.** Illustration of concrete masonry wall retrofitting (a) Broken part of masonry wall; (b) Removed part of masonry wall

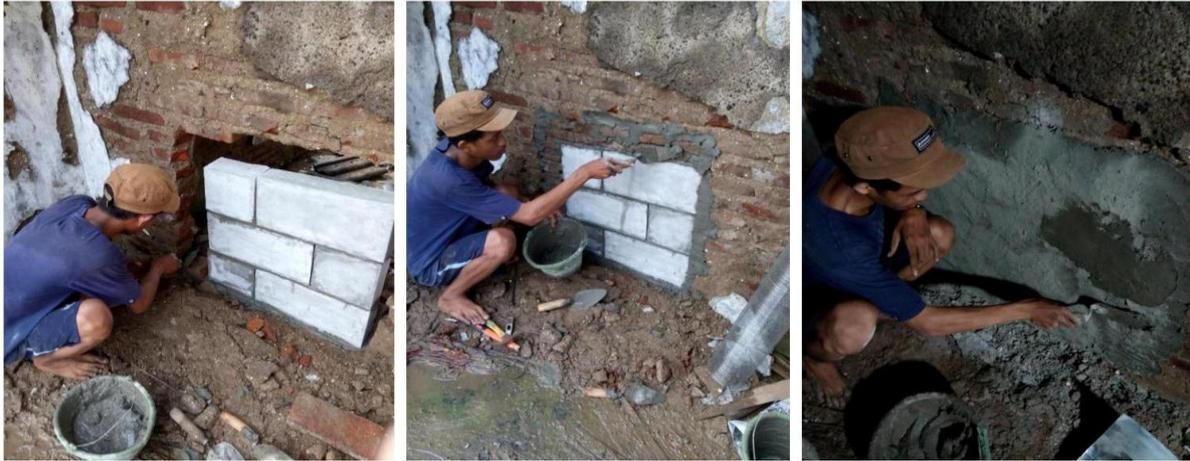
**Fig 9.** Retrofitting of masonry wall in site – (a) Filling the removed part by concrete bricks; (b) filling the space between new concrete bricks and the old masonry wall; (c) Plastering the retrofitted masonry wall

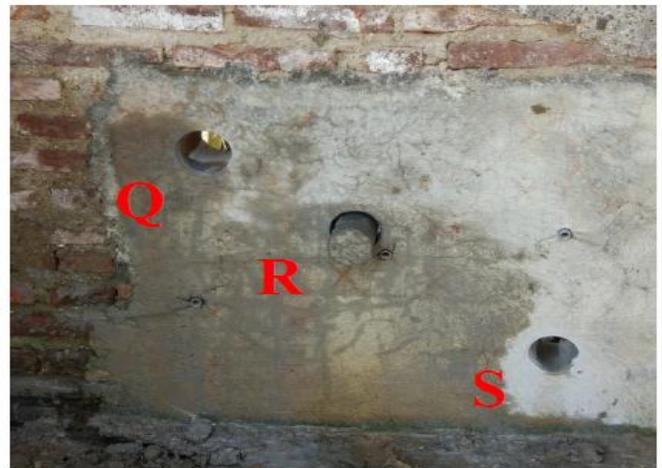
**Fig 11.** Core Drill sampling of retrofitted masonry wall

The cylinder specimens of Core Drill Test were taken out of the 0.5 x 0.5 m<sup>2</sup> of concrete masonry walls which was retrofitted part of broken masonry wall (Fig 11). Three core samples as described by Fig 11 were at point Q, R, and S which were aligned diagonally at the wall surface. Dimension of cylinder specimens of Core Drill Test described by Table 4 and Table 5.

Table 4 (Pucang Gading village) and Fig 17 have shown the lowest compressive strength at point R, P-D-B-02A was very low (31.22 MPa). This could be influenced by crack around the point that caused by anchor during drilling. However, the point S (Fig 11) has shown lower compressive strength (65.03 MPa) compared to the compressive strength at point Q (82.64

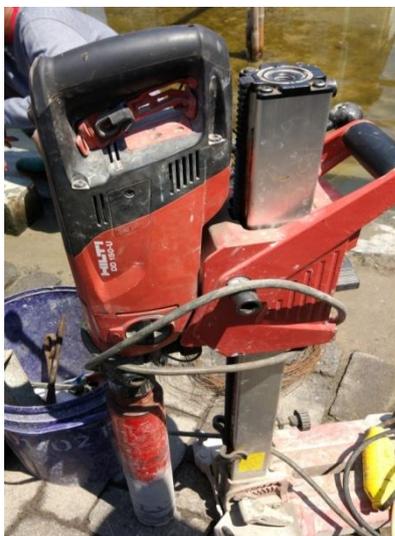
**Fig 10.** Core Drill Machine

Core Drill Test was carried out in nearly the end of 2017 in Sriwulan village and also in Pucang Gading village sites. This is a semi-destructive testing which referred to ASTM C 42/C 42M-04 Method for Obtaining and Testing Drilled Cores and Sawed Beams of Concrete, ACI 214.4R-03 Guide for Obtaining Cores and Interpreting Compressive Strength Results, and also Indonesia National Standard, SNI 03-2492-2002 Method of Obtaining and Testing Drilled Cores. Apparatus for obtaining the samples was a drill machine with diameter of 3 inch as shown by Fig 10.

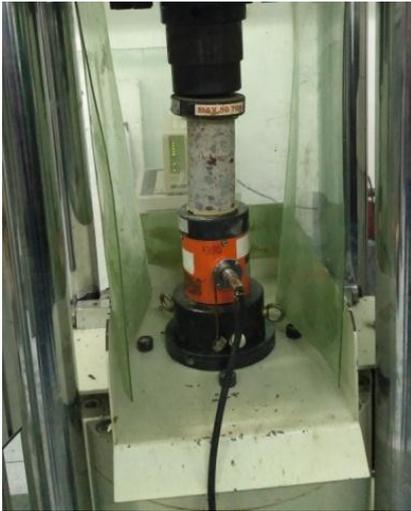
**Fig 12.** Computer Control Servo Hydraulic Concrete Compression Testing Machine

Core Drill specimens were tested for compressive strength at age 14 months by Computer Control Servo Hydraulic Concrete Compression Testing Machine, Hung-Ta HT 8391PC with Load Cell and Data logger as shown by Fig 12.

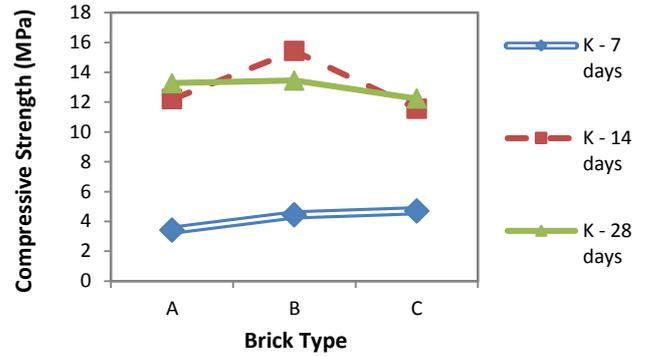
**Fig 14.** Compressive strength of K series of Main-Experiment stage at age 7, 14, and 28 days

Fig 14 described compressive strength development of K series. K-A seemed to have highest compressive strength (13.28 MPa) since its final compressive strength value at day 28 days was not decreasing as other specimens did. Specimens of A type had been reached highest value of compressive strength (15.88 MPa) in K1 series (Fig 15) and also in K3 series that highest compressive strength (16.13 MPa) (Fig 16).

For Main-Experiment stage, we investigated the compressive strength of brick specimens with series of K, K1 and K3, at 7, 14, and 28 days, as described by Fig 14, Fig 15, and Fig 16.

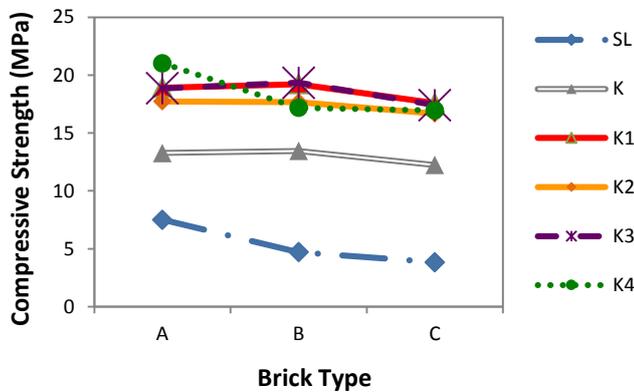
**Fig 13.** Compressive strength of specimens of Pre-Experiment stage

Pre-Experiment specimens were tested for compressive strength and clearly described by Fig 13 that product specimens (SL-A,B,C) have the lowest compressive stress (3.8 MPa to 7.5 MPa) followed by control specimens (12.25 MPa-13.45 MPa). Higher compressive stress achieved by K1, K3, and K4 brick specimens, about 16.67 MPa-21.03 MPa. However, for K4 specimens, there was only K4-A reached the highest performance but not the others. It was obvious that the optimum compressive strength achieved by K1 and K3 series, then both of mix compositions used for Main-Experiment step.

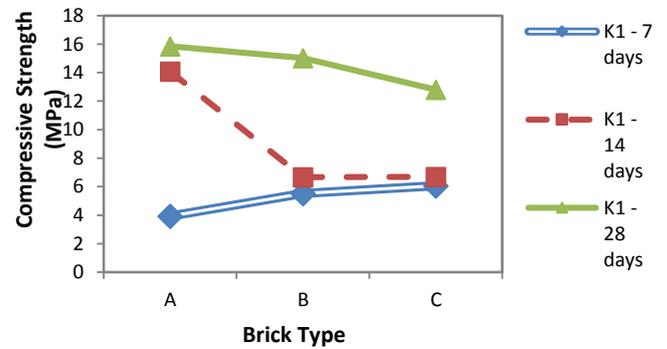
**Fig 15.** Compressive strength of K1 series of Main-Experiment stage at age 7, 14, and 28 days

Development of compressive strength of K1 series and K3 series performed good values, but K3 series has shown better performance it is optimum. K3 series had never shown decreasing of compressive strength but K1 series did, even a little bit dramatic at age 14 days. Hence, the optimum compressive strength is K3 series with A type. The production of bricks for field application then used K3-A composition for retrofitting the broken masonry wall.

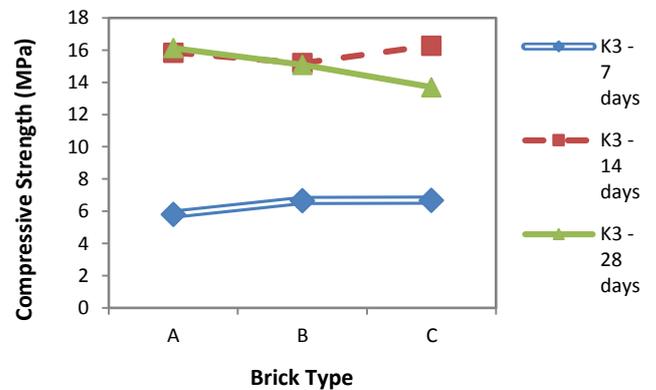
**Fig 16.** Compressive strength of K3 series of Main-Experiment stage at age 7, 14, and 28 days

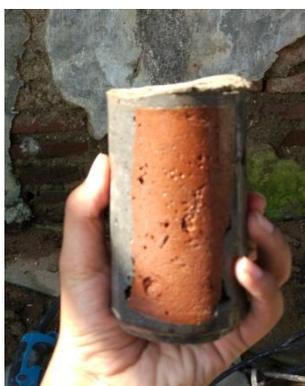
**Fig 17.** Core Drill specimen

Core drill specimens taken out of broken masonry wall in two sites, Pucang Gading village and Sriwulan village were cylinders as shown by Fig 17. Compressive strength of the specimen calculated by concerning several correction factors as detailed by Table 4 and Table 5 as it previously reported in [9].

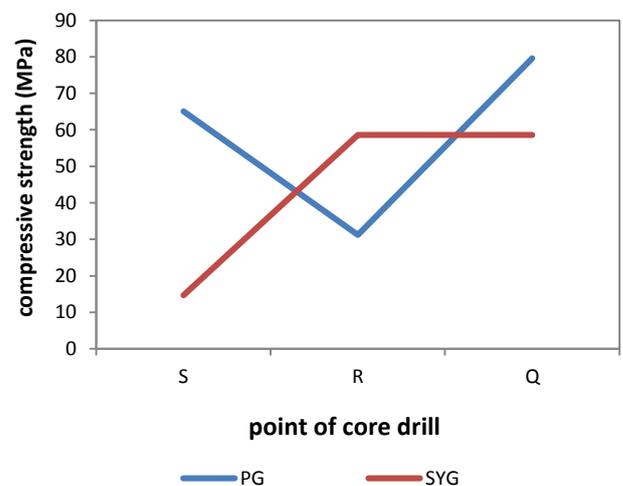
**Fig 18.** Compressive strength of Core Drill specimens

Core drill specimens from Sriwulan village have shown different result because of the site is continuously submerged by tidal flooding, hence the environment becomes aggressive. Table 5 and Fig 18 have shown that lowest compressive strength (14.68 MPa) achieved by specimen taken out of point S, in the bottom of the masonry wall, compared to other points (58.60 MPa and 58.61 MPa).

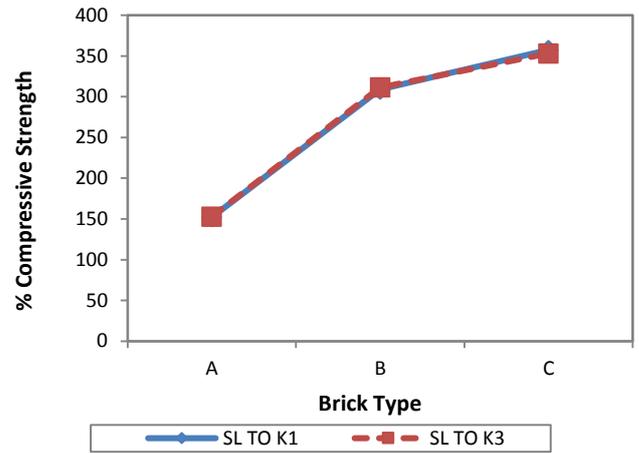
**Fig 19.** Comparative value of specimen compressive strength between K1-K3 and SL

It is interesting that compressive strength of K1 and K3 series specimens only 40% compared to K as control specimens (Fig 18) while those series have very high compressive strength compared to SL (Fig 19), manufactured product (Fig 20), about 150-350% higher. K3-C series compressive strength was found 353.13 % higher compared to SL. Therefore, the natural polymers of *Moringa oleifera*, *Gracilaria Sp.*, and also honey, have contributed to increase the performance of concrete bricks by providing extra bond mechanism. As reported by [11], agarose and agaropectin in *Gracilaria Sp.* provide strong gel that increase the bond mechanism of concrete brick. Previous researches [12][13] also noted that *Moringa oleifera* contains glycerol that has proven to increase bond and strength of mortar and concrete compressive strength. Addition of honey was also provided better bond mechanism since there was significant increase of compressive strength of K1 series. Therefore, the good performance of concrete bricks can be expressed by linear relation between K1-K3 series to K and SL with increment of compressive strength as described by Fig 20.

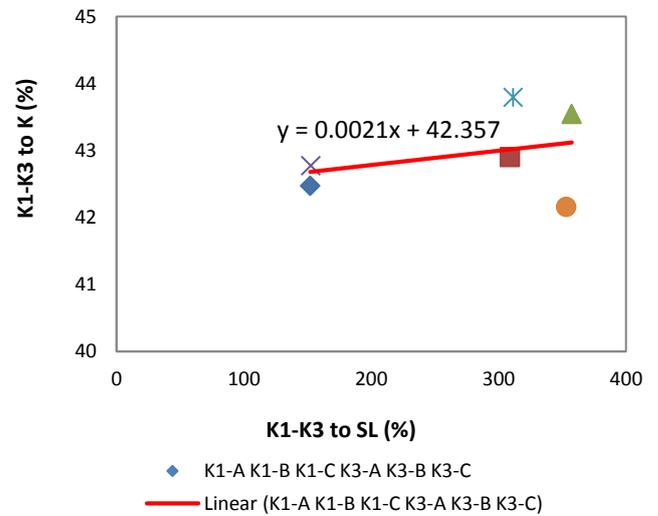
**Fig 20.** Relation between % K1-K3 to K to % K1-K3 to SL

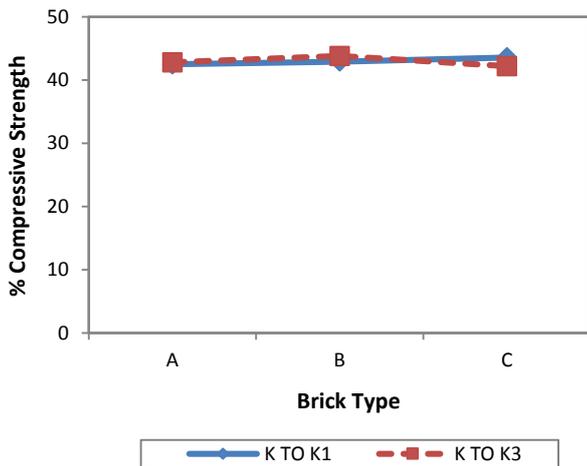
**Fig 18.** Comparative value of compressive strength between K1-K3 and K

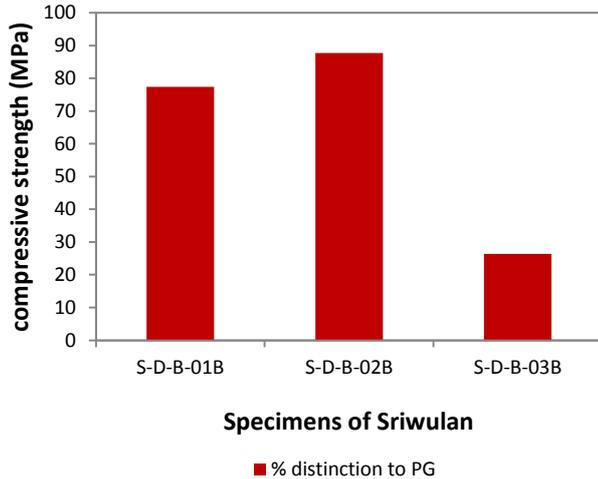
**Fig 21.** % distinction of specimens Sriwulan to specimens Pucang Gading

Good performance of concrete bricks shown by experiment results was also perform very satisfied in application to retrofit the broken masonry wall [15] as described by Fig 21. It is emphasized that core drill test specimens in Sriwulan village that continuously submerged by seawater perform good compressive strength from 77.42% to 26.34% compared to Pucang Gading specimens. The lowest value of compressive strength in Fig 21 was achieved by point S that was suffered by great exposure of seawater because it was laid on the bottom of the concrete masonry wall.

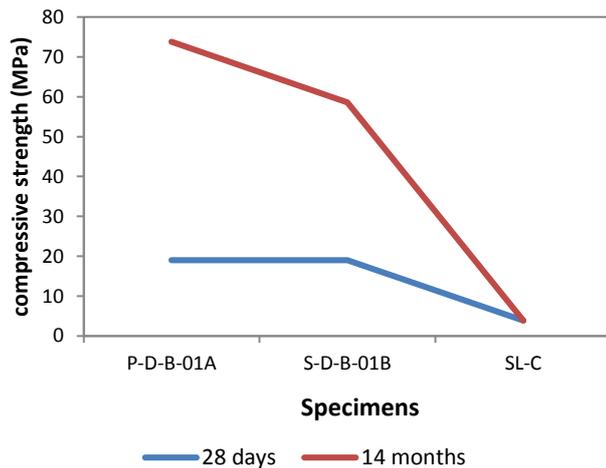
**Fig 22.** Comparison of compressive strength among specimens

Durability of concrete masonry wall was clearly defined by Fig 22. Compressive strength of 28 days old concrete brick with natural polymers increase about four times (73.84 MPa) when it is applied to concrete masonry wall in dry area of Pucang Gading village and about three times (58.61 MPa) in tidal flooding prone area of Sriwulan village at age 14 months. Eco-concrete bricks with natural polymers of *Moringa oleifera*, *Gracilaria Sp.*, and also honey provide great performance in compressive strength increase.
