Effect of Dam Construction on Vegetation Cover and Shoreline: A case study

Shivangi Mishra¹, Priyanka Dhurvey², Subha Sinha^{3*}, Pallav Kumar⁴

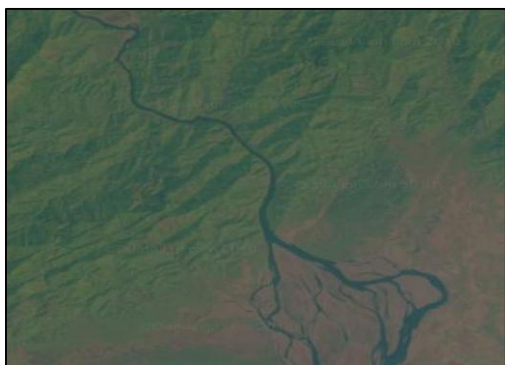
Fig 1.RGB image for year 1999

The six steps shown in methodology section were followed for the year when dam was not constructed. Figure 1 to Figure 6 depicts the images obtained through different steps of methodology. The images directly obtained from the website are shown in Figure 1 and Figure 2. NDWI image and NDWI logical images are shown in Figure 3 and Figure 4. The logical images show the places where watershed along the dam shoreline is affected positively or negatively based on code generated. Similarly, NDVI image and NDVI logical images are shown in Figure 5 and Figure 6.

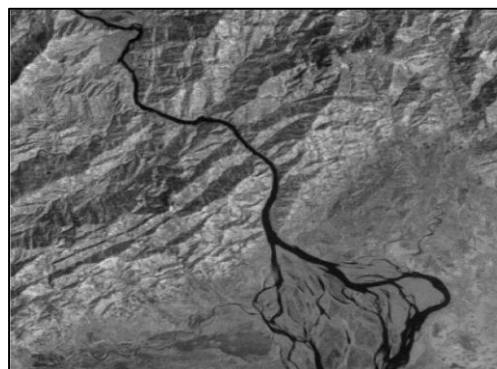
Fig 2.NIR image for year 1999

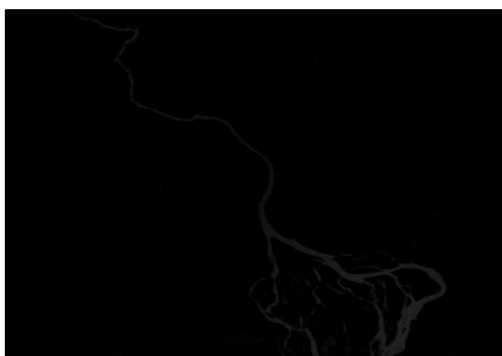
Fig 3. NDWI image for year 1999

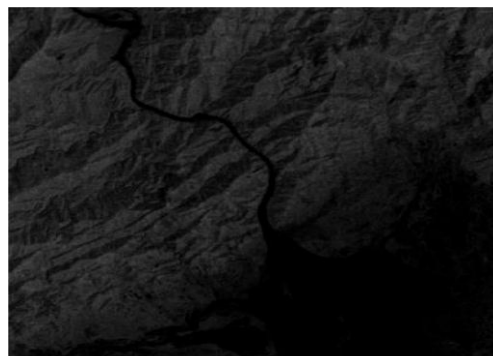
Fig 4. NDWI logical image for year 1999

using MATLAB coding. The values of NDWI and NDVI which were smaller than 0 were designated as '0' showing no change in the vegetation or dam shoreline. However, the values greater than 0 were designated as '1' showing the change in the vegetation or dam shoreline. For this purpose, 'XOR' operation of coding language was used.

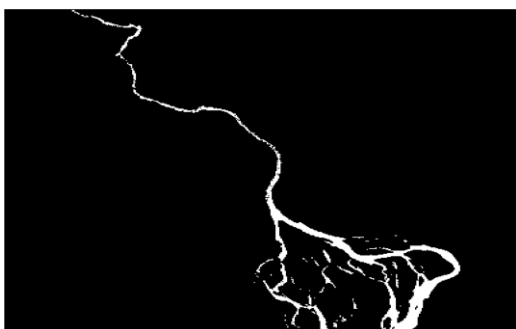
Fig 5. NDVI image for year 1999

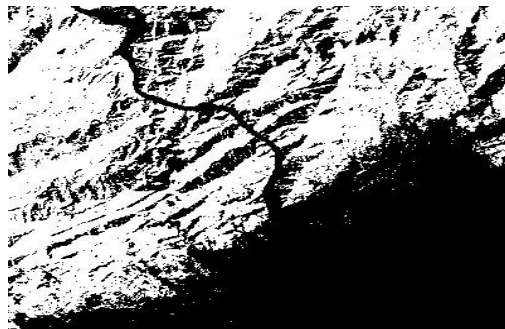
Fig 6. NDVI logical image for year 1999

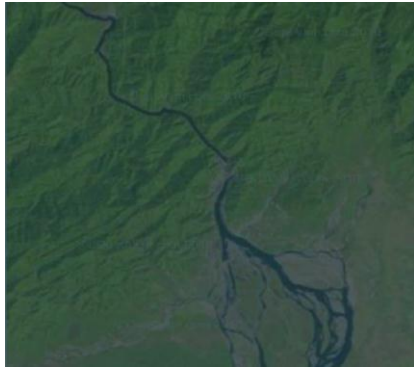
Fig. 7 RGB image for year 2010

Similar procedure as shown in previous section was applied for the year 2010, just after dam construction. Figure 7 and Figure 8 shows the RGB image of Subansiri Dam and NIR image of Subansiri Dam, respectively, obtained from website, as explained in methodology section. Figure 9 and 10 shows the NDWI image and NDWI logical images whereas; Figure 11

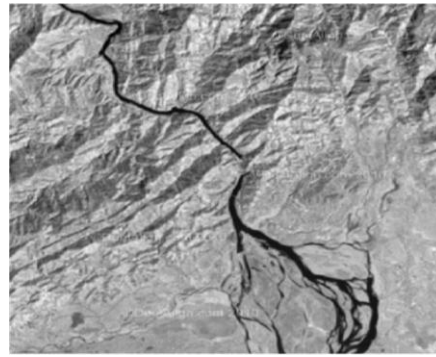
Fig 8.NIR image for year 2010

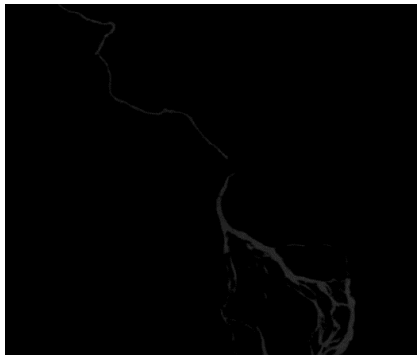
Fig 9. NDWI image for year 2010

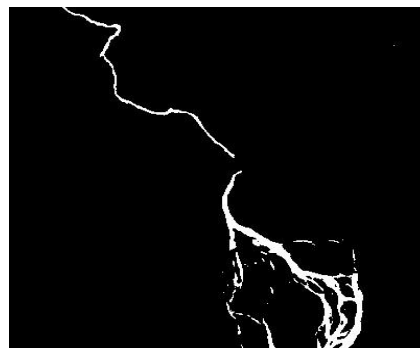
Fig 10. NDWI logical image for year 2010

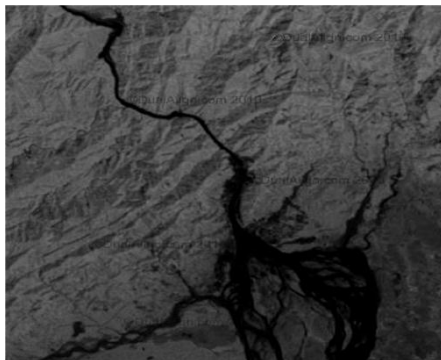
Fig 11. NDVI image for year 2010

and 12 represents the NDVI and NDVI logical images.

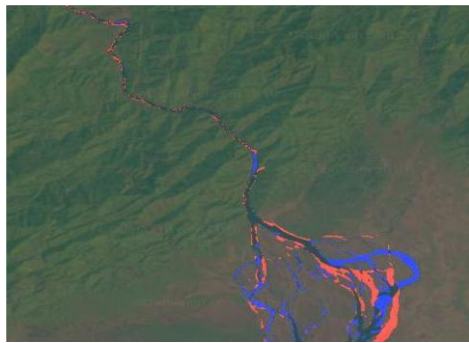
Increment in dam shoreline

Decrement in dam shoreline

Fig 13. Changes in dam shoreline (1999-2010)

The map of the changes in the dam shoreline and vegetation before and after construction of dam is shown in Figure 13 and Figure 14, respectively. From Figure 13, it is observed that dam shoreline has increased at different places but also, at some places, there are decrements observed. However, in case of vegetation, as shown in Figure 14, there is considerable decrement in growth.

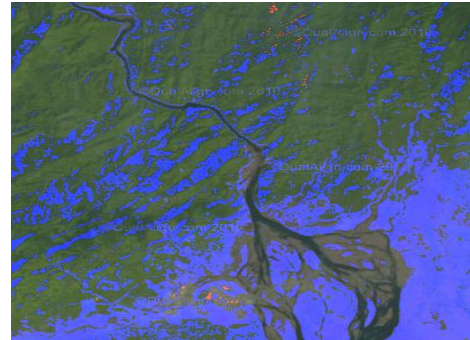
Change Map (Red - increment in Vegetation, Blue - decrement in vegetation, 1999-2010)

Increment in vegetation cover

Decrement in vegetation cover

Fig 14. Changes in vegetation cover (1999-2010)

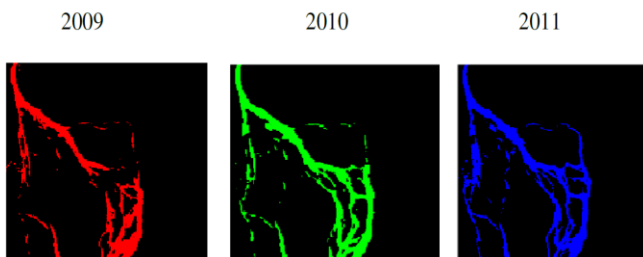
Fig 15. Change in Dam Shoreline Logical images from 2009 to 2011

To understand the changes in vegetation cover and dam shoreline over the years, the logical images were obtained for three consecutive years; 2009, 2010 and 2011. Based on the logical images, the area values are calculated using number of pixels for the entire area of 30*30 km² taken into consideration for the present study. The changes in dam shore line over the years are depicted in Figure 15 and area affected are shown in Table 1. The changes can be easily observed through Figure 15 for different years. Moreover, if 2009 is considered as base year, as shown in Table 1, the change in dam shoreline is found to be have increased by 17 % (in terms of area) for the year 2010 and 33% (in terms of area) for the year 2011, which is considerably high.

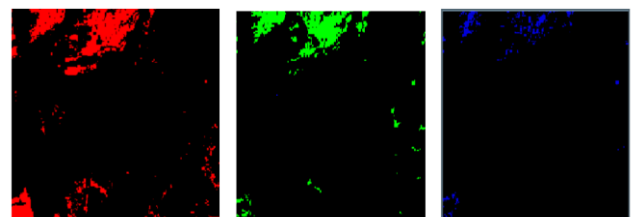
Fig 16. Change in Vegetation Cover from 2009 to 2011

images of vegetation cover from year 2009 to 2011. The changes are depicted in Figure 16 and Table 2. It can be clearly identified from Figure 16 that the vegetation cover has been considerably decreased due to the construction of dam over the years. To quantify this effect in terms of area of vegetation cover, area of vegetation cover was obtained based on the pixels of the logical images generated. If 2009 is considered as base year, the area of vegetation cover is reduced by 35 % and 80% respectively for the overall area of 30*30 km² taken into consideration. This clearly shows that vegetation cover is substantially affected due to construction of dam over the years.
