Evaluate the Performance of Service Buildings in the Operational Stage (Case study of service buildings in the Mansheyat Nasser housing development project in Cairo governorate)

Dalia Ahmed Refaee Mohamed^{1*}, Hossam Eldin Hassan Othman Elbrombaly² and Akram Farouk Abdel Latif³

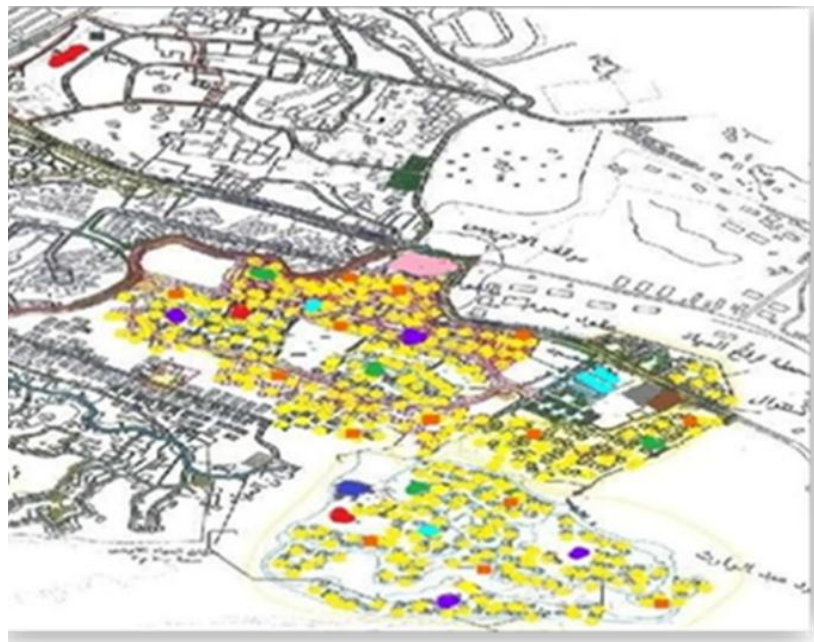
Fig. 2. Plan showing the layout components of Manshiyat Nasser project

commercial buildings, industrial craft buildings, religious buildings, educational buildings, police buildings, transportation centers, water tanks, a water pumping station, green areas. Central, open playgrounds, etc. (25), as shown in Figure 2.

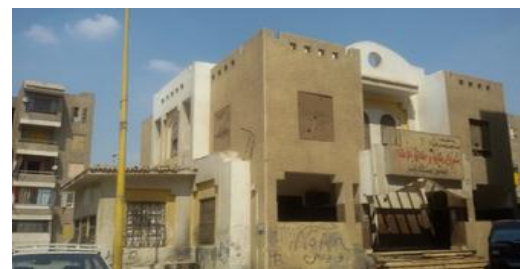
Fig. 3. The Motherhood and childhood care center building from the main front façade

- The owner of this building is the Greater Cairo Authority of the Ministry of Housing and Construction.
- The building consists of a ground floor and a first floor as shown in Figures 3-5.

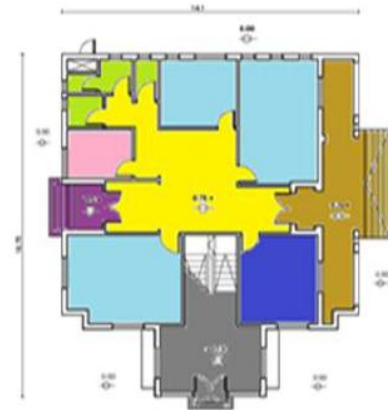
Fig. 6. Ground floor plan of the nursery in the Motherhood and Childhood care center building before the changes

- The National Council for Motherhood and Childhood rented the ground floor from the Greater Cairo Authority of the Ministry of Housing and Construction and was used as a nursery, while the left side is used as an entrance to the first floor.
- There was a back entrance in the back facade of the nursery on the ground floor on the side opposite the main entrance in the front facade of the nursery as shown in Figure 6.

- The main entrance to the nursery
- The back entrance to the nursery
- The nursery director's office room
- Nursery classrooms
- Distribution spaces
- Unisex toilet
- Kitchen
- Entrance leading to the health unit stair that on the first floor

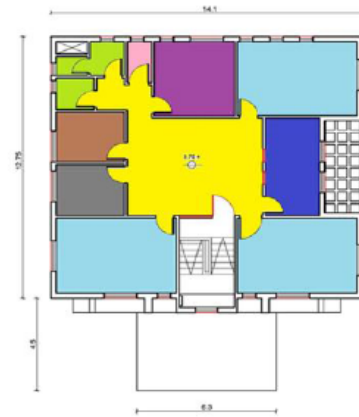
Fig. 9. First floor plan of the Motherhood and Childhood Care Center building, after the changes

- A change was made in the first floor of the health unit by opening windows in the pharmacy to deal with patients, and one of the toilets on the first floor was transferred to an office. Wrought protection iron was also installed as protection on all window openings to

prevent thefts, looting and thuggery as shown in Figure 9. Also, a door and fixed partitions made of Wrought protection iron were installed next to it to protect the entrance of the health unit on the first floor as shown in Figure 10.

- Patient waiting area with a door to the entrance and a window by wrought iron
- Pharmacy, two windows were opened in its inner wall overlooking the patient waiting area, and a protective wrought iron was installed
- Medical analysis laboratory
- Unisex toilets
- Account management room
- The health unit director room
- Clinic rooms
- Kitchenette
- Protective wrought iron on all exterior windows, pharmacy interior windows, health unit entrance door and window

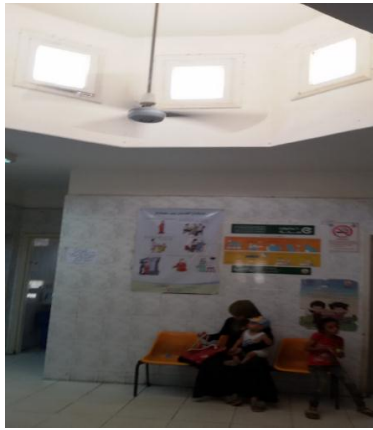
Fig. 12. The small area of the health unit in the first floor

- The absence of a radiology center in the health unit in the first floor, with the absence of many other specialties due to the small area of the first floor as shown in Figure 12.

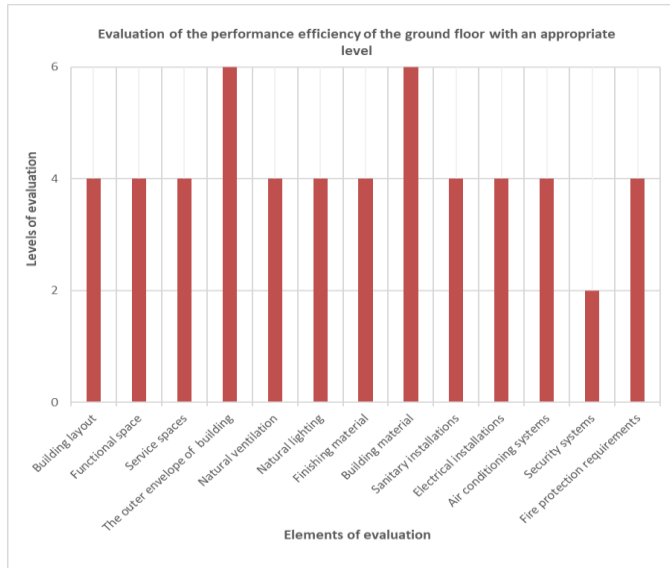
Fig 13. Diagram to evaluate the efficiency of the performance of the ground floor in the building of the Motherhood and Childhood Care Center after the changes

You may notice from the above that the evaluation of the performance efficiency of the building of the Motherhood and Childhood Care Center, falls at the appropriate level as shown in figures 13, 14. Therefore, a strategy is proposed to raise the efficiency of the performance of these buildings to fall between the appropriate level and the distinguished level as possible.

The evaluation levels were coded according to the following:

(2) Inappropriate (4) Appropriate (6) Distinguished

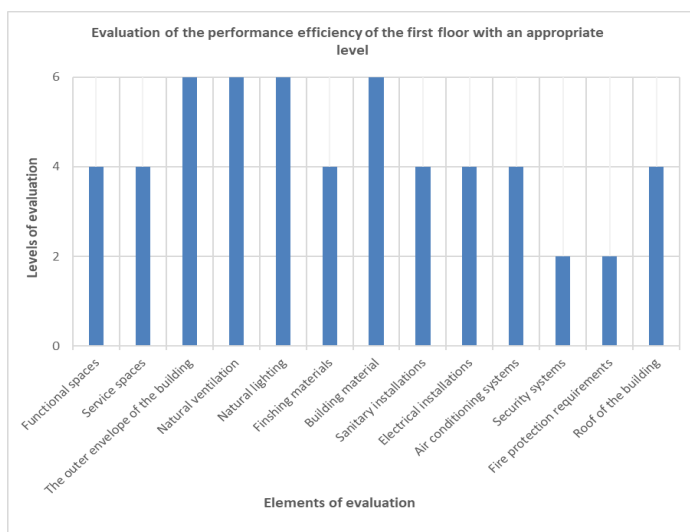
Fig 14. Diagram to evaluate the efficiency of the performance of the first floor in the building of the Motherhood and Childhood Care Center after the changes

The evaluation levels were coded according to the following:
